5.0 WATERSHED ACTION PLAN FOR PRIORITY SUBBASINS

LAKE COCHITUATE PRIORITY SUB-WATERSHED ASSESSMENT	
AREA 1: North Pond Sub-watershed	
SITE NP-FR-1	Lakeview Road Drainage
Location	Lakeview Road, Framingham
Site Description	Lakeview Road is a residential street that runs along the shore of North Pond. Stormwater from this area is collected in a series of catch basins and discharged directly to North Pond through a series of four outfall pipes (see Map 9).
Issues/Problems	<p>1) Where Lakeview Road dead ends near the bank of North Pond, there are two catch basins that are not collecting the stormwater flow from the road because they are clogged. As a result of the failed catch basins, stormwater overtops the curb at the dead end of Lakeview Road and flows overland across the yard of the adjacent home, then rushes down the steep slope, causing significant erosion and sedimentation. The homeowner has a set of wooden stairs on the slope which show evidence of sediment deposition, and the roots of trees on the slope have been scoured and undercut by the stormwater flow. Framingham's drainage plan shows these 2 catch basins connected to the outfall southeast of the site. But it appears tha

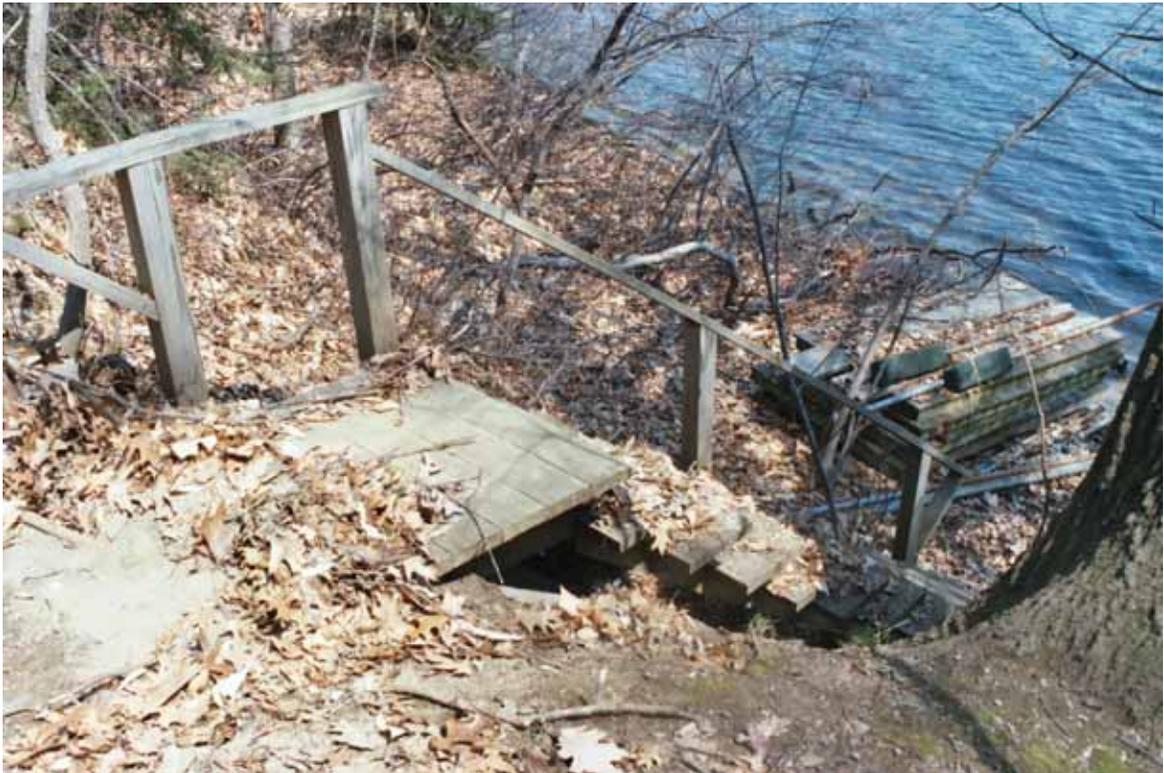
Erosion and Sedimentation on Slope

Recommended Actions / BMP's	<p>The clogged catch basins on the dead end of Lakeview Road need to be cleaned out, and the pipe connecting to the outfall should be inspected to insure that flow is not obstructed in the line. Once flow is restored from these catch basins to the outfall, the slope erosion problem should be ameliorated</p> <p>Given the high degree of sediment buildup both at the dead end catch basins and in Finley's Cove, pre-treatment for total suspended solids before discharge to the lake is recommended. This could be accomplished with the replacement of the existing catch basins with deep sump catch basins. Estimated cost of these is about \$2500 to \$3,000 each. There are two catch basins at the dead end of Lakeview Road, and there are about 10 that are tributary to Finley's Cove. Another alternative for the Finley's cove area could be the installation of a hydrodynamic separator before the stormwater is directed to the outfall. This could capture and retain much of the sediment in one location for the entire subdrainage area. There are several hydrodynamic separators commercially available (see Appendix). Preliminary cost estimate is \$50,000 (\$35,000 for the unit and \$15,000 for installation. For either type of BMP, maintenance will be critical.</p>

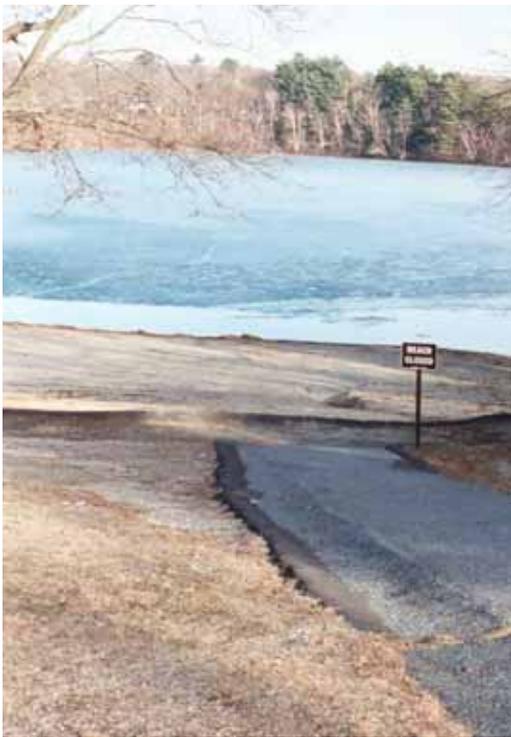
SITE NP-FR-2	Framingham Town Beach
Location	Corner of Old Connecticut Path and Lake Road, Framingham
Site Description:	The site has a moderately steep slope from the road down to the shoreline; the upper part of the site is partially paved and partially grassed, the lower part of the site is the sand beach. A stormwater outfall is located next to the swimming beach; this discharges runoff from the beach parking lot.
Issue/Problem	<p>(1) Erosion: runoff from the upper portion of the site causes erosion on the lower part of the site. An asphalt walkway concentrates the runoff, causing erosion which has formed a shallow gully along the west edge of the site.</p> <p>(2) Runoff: the parking lot outfall discharges directly to the swimming beach.</p>
Recommended Actions / BMP's	<p>(1) Erosion: site drainage could be reconfigured to avoid the concentration of runoff. This could be done with regrading and the addition of a vegetated buffer strip to collect and slow the runoff before it is discharged.</p> <p>(2) Runoff: A pre-treatment device should be added to the stormwater system. Given confined space, a hydrodynamic separator would be the best option. A similar proposal for this site was submitted to EPA by the Framingham Planning Dept. as a Supplemental Environmental Project in 2001. BMP's proposed included improvements to catch basins, relocation of existing stormwater inlets, and installation of a sediment settling chamber. The cost was \$133,500. An updated cost estimate for 2004 is about \$150,000.</p>

Paved walkway above Town Beach

- Site drainage could be reconfigured to avoid the concentration of runoff which is causing erosion above the beach. This could be done with regrading and the addition of a vegetated buffer strip to collect and slow the runoff before it is discharged.

- A pre-treatment device should be added to the stormwater system. Given confined space, a hydrodynamic separator would be the best option. Such a system could remove most suspended sediments and other pollutants associated with the sediments.

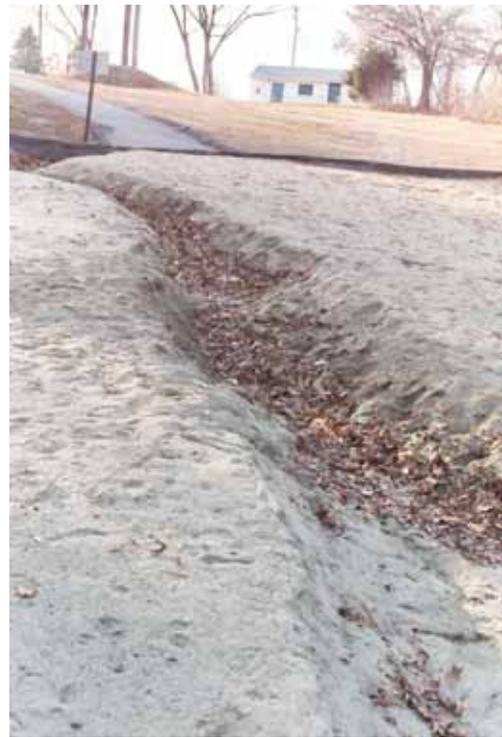
Erosion above the Town Beach

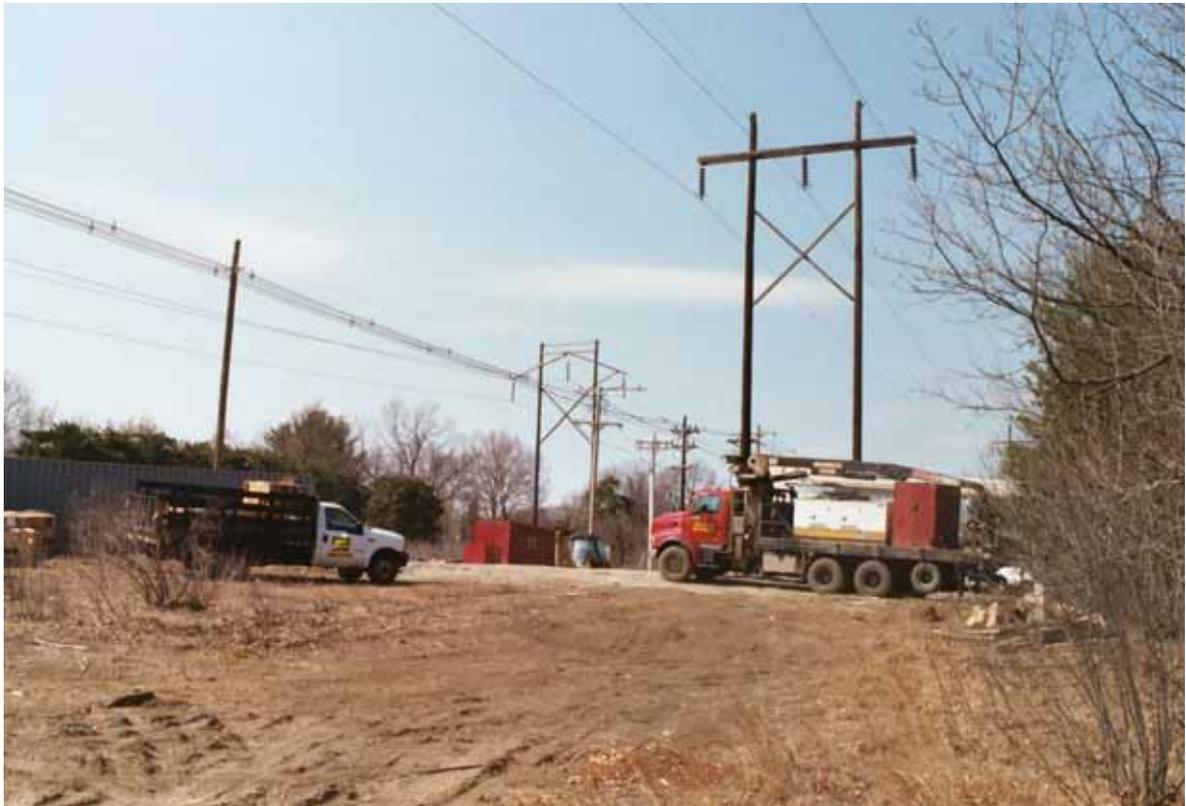
SITE NP-FR-3	NSTAR Electric Transmission Right of Way / Vehicle Storage
Location	Framingham and Wayland, across the northern side of North Pond.
Site Description:	A Boston Edison utility right of way (ROW) passes to the north side of North Pond, within a few feet of the town beach. There is a utility truck and vehicle storage yard on the ROW just off of Lakeview Road in Framingham.
Issue/Problem	Trucks and other vehicles are a potential source of fuel, oil and grease. The vehicle yard is unpaved, exposed earth, with the potential for erosion and sedimentation.
Recommended Actions / BMP's	The site should be inspected to ensure that good housekeeping measures are in effect and no inappropriate materials or chemicals are being stored or used on the site. The site should be maintained to reduce the potential for erosion, perhaps by adding crushed stone to the unpaved areas of bare earth and maintaining a vegetated buffer.

NSTAR Utility Right of Way with Vehicle Storage

- The vehicle storage yard should be inspected to ensure that good housekeeping measures are in effect and no inappropriate materials or chemicals are being stored. The site should be maintained to reduce the potential for erosion.

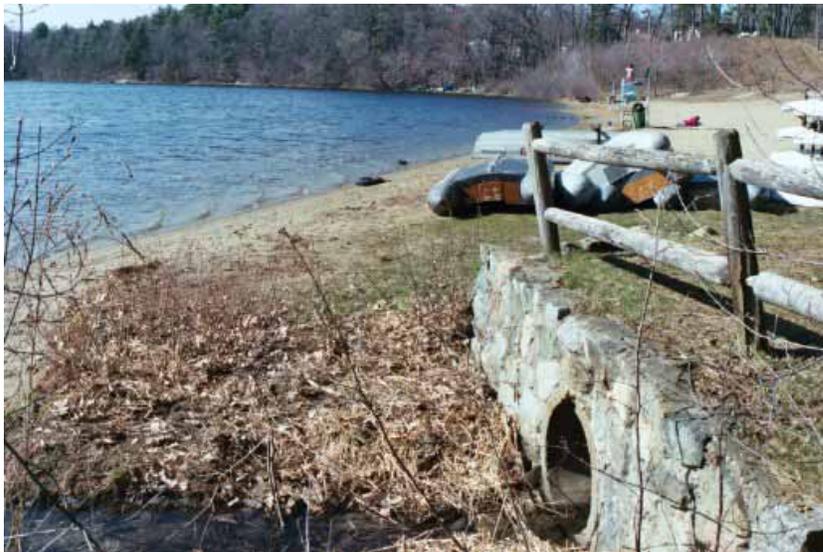
SITE NP-WA-2	Stormwater outfall at Wayland Town Beach
Location	Wayland Town Beach, off of Parkland Street
Site Description:	A stormwater outfall discharges to North Pond on the south side of the Wayland Town Beach. The outfall discharges stormwater from the parking lot next to the beach and adjacent town roads.
Issue / Problem	The outfall location results in the discharge of stormwater directly in the area of the town beach. This is a direct discharge with no mitigation of stormwater quality. A discharge of this sort would not be in compliance with DEP stormwater standards today. The outfall pipe has several inches of sediment and muck deposits in it which have an oily appearance. Reinspection of this site in spring 2004 found that much debris had accumulated below the outfall, and a makeshift grate had been placed over the outfall, secured by some logs.
Recommended Actions / BMP's	Since this is a town owned facility and is heavily used by the public, it is recommended to mitigate this stormwater discharge, which could not only improve this site, but also serve as a demonstration project. The site could be retrofitted to provide pre-treatment of the stormwater before it is discharged to the lake. A potential mitigation measure for the parking lot portion of the stormwater is the retrofitting of low impact development techniques that provide filtration through vegetated buffers. A similar site in Acton is being retrofitted with Filterra units, which may be useful for this site (see Appendix). For the overall flow coming from adjacent town roads, the installation of a pretreatment device such as a hydrodynamic separator is recommended. The estimated cost of this option would be about \$50,000, \$35,000 for the unit and \$15,000 for installation. After the installation of BMP's, ongoing maintenance will be critical to their performance in order to achieve water quality benefits.

Stormwater Outfall in close proximity to the beach

- The site should be retrofitted to provide pre-treatment of stormwater before it is discharged. A potential mitigation measure for the parking lot is the retrofit of low impact development techniques that provide filtration through vegetated buffers
- For the overall stormwater flow coming from adjacent town roads, the installation of a pretreatment device such as a hydrodynamic separator is recommended.

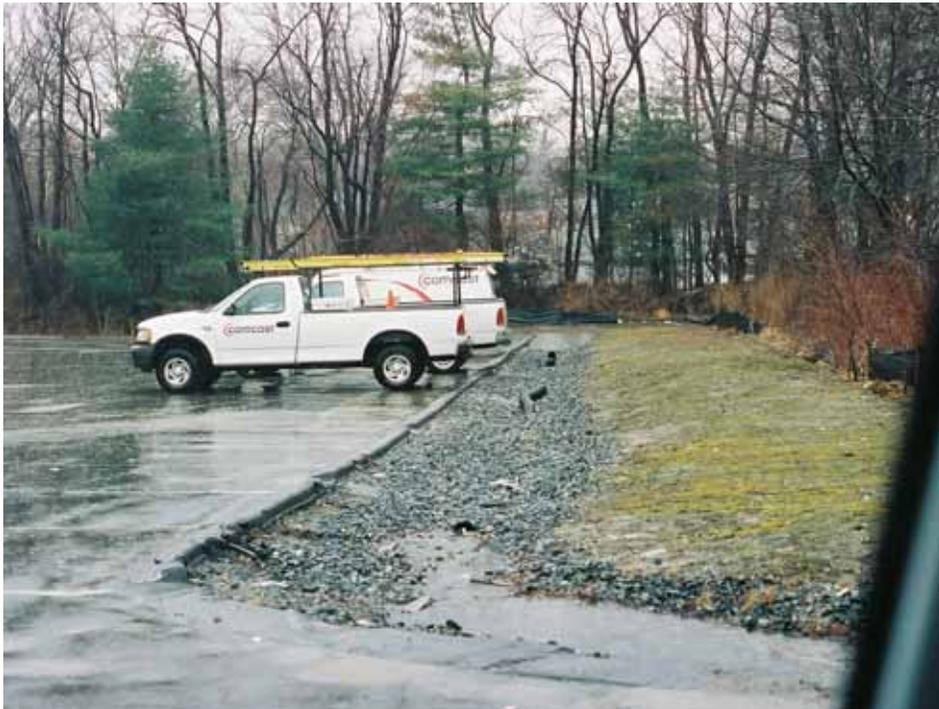
LAKE COCHITUATE PRIORITY SUB-WATERSHED ASSESSMENT AREA 2: Beaver Dam Brook Sub-watershed	
SITE BB-NA-5	West Central Street Commercial Area
Location	Area bordered by Boden Lane to the west and Mill Street to the east, RR tracks to north and West Central Street to south , Framingham.
Site Description	Roughly 116-acre commercial/industrial district with high percentage of impervious area just south of Beaverdam Brook. The site has been delineated into three delineated NPS sites: 1) the Comcast site at 241 West Central, 2) 233-235 West Central Street, and the 3) the Barber Brothers parcel just east of the 233-235 West Central St.
Problem and Recommended Action/BMP	<p>Site 1: About 26-acres in size. Currently, sheet flow is running west to east across a paved parking area in front of and around the Comcast Building to Beaverdam Brook. The stone collecting swale presently in place would be replaced with a it with a series of 5 catch basins placed at 100-foot intervals alongside the stream. The first flush would be handled by TSS removal units for each catch basin and the basins would be equipped with overflow devices (estimated cost, \$80,000).</p> <p>Site 2: Approximately 6-acres in size, this portion of the overall site is paved and its sheet flow runs from west to east to Beaverdam Brook on its western border. Attenuation here could be accomplished by placing a series of three catch basins in the existing low area of the site to treat flows. TSS removal units would accompany each catch basin and overflows could be run to the existing pocket wetland onsite (estimated cost, \$70,000).</p> <p>Site 3: Just east and south of Barber Brothers, a series of existing catch basins collect untreated stormwater where it is piped underneath the RR tracks and then to Beaverdam Brook. A possible solution here would be insert into a drain line manhole an appropriately sized TSS removal unit as close as possible to the RR tracks to gain maximum treatment benefit (estimated cost, \$50,000).</p>

Drainage system is failing after winter ice & snow lifted the drainage pipes

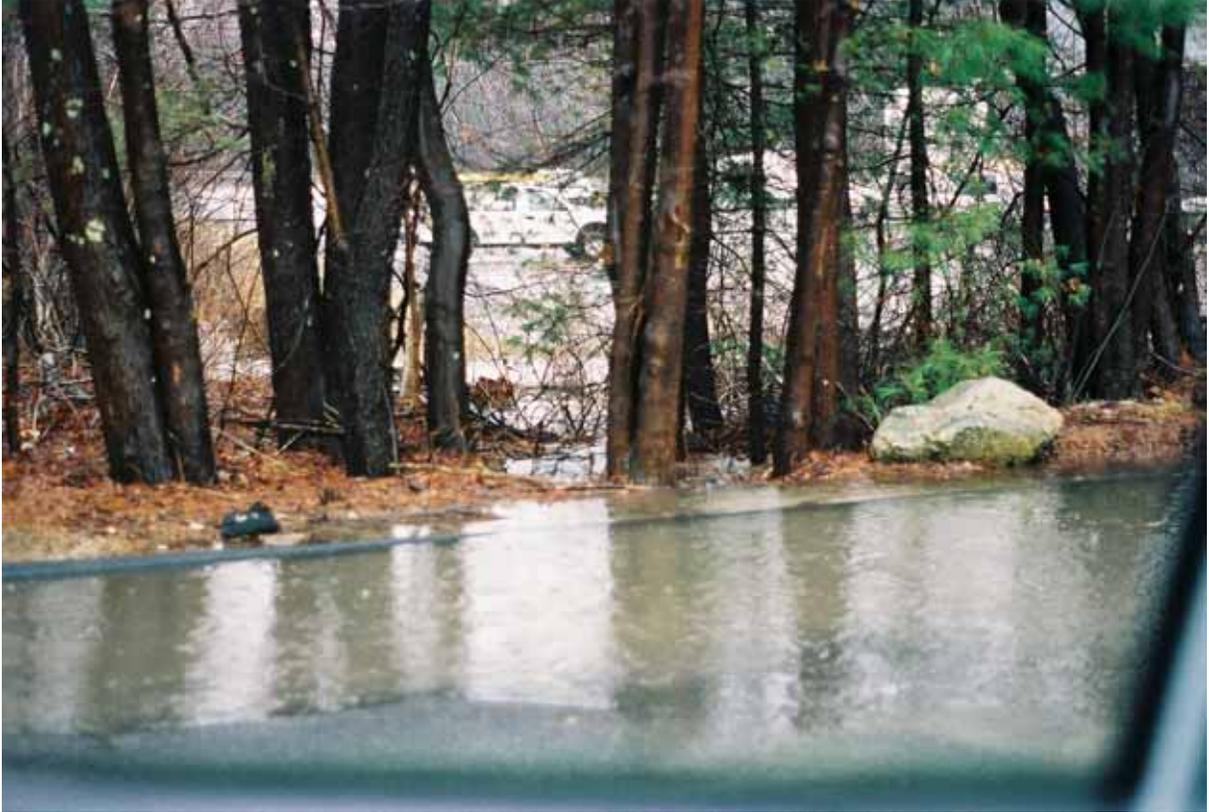
Photos show parking lot drainage directly emptying to and impacting the drainage tributary draining to Beaver Dam Brook

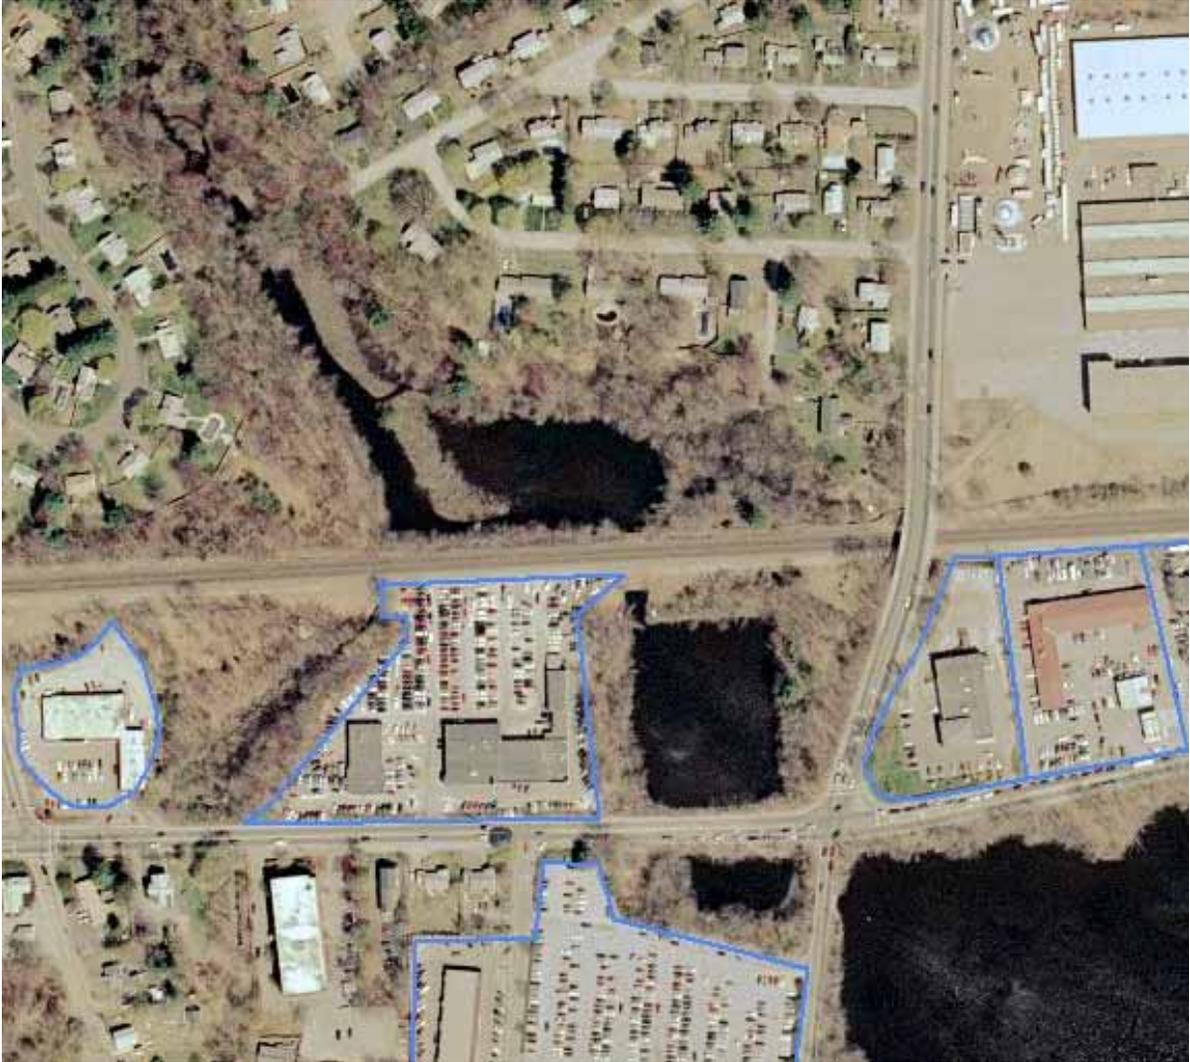
LAKE COCHITUATE PRIORITY SUB-WATERSHED ASSESSMENT AREA 2: Beaver Dam Brook Sub-watershed	
SITE BB-NA-6	Beaver Dam Brook Settling Basin
Location	Between Speen Street, West Central Street (Rt. 135) and the RR tracks Basin is adjacent to the Mitsubishi dealership
Site Description	The settling basins are at the end of Beaver Dam Brook before the brook enters Fiske Pond.
Problem	<ul style="list-style-type: none"> • These basins slow the flow of water allowing sediment to settle to the bottom. Sediments and nutrients have accumulated to the point that the basins have become ineffective at trapping or allowing for settling out of further sediments. • Trash from Rt135 traffic, trash from shopping plaza parking lot, and trash from upstream sources • Turbidity and sedimentation • Algae build up in summer
Recommended Actions / BMP's	<p>Several reports in the past have recommended dredging the settling basins. The associated costs with first dredging and second, the disposal of the potentially contaminated sediments, seem to have rendered this project solution unfeasible. Accordingly, the current recommendation is to build a rock fore-bay at the start of the settling basin. The fore- bay would be big enough to hold and slow the brook's flows and would be engineered so as to not restrict flows during major storm events. The project would attempt to slow the brook's flow using the same principle as the settling basins original design but on a smaller scale. The smaller scale may allow for easier maintenance and less cost. The system design would allow for some detention of stream flows, allowing some settling out of sediments.</p> <p>The recommended area has very good access and municipal ownership. Expected costs would be in the \$500,000. range.</p> <p>Other recommendations for this site are: A clean up of the surrounding land and wetlands and an enforceable maintenance plan for the adjacent parking lots. This should help reduce local sediment input. (note pictures of trash in wetlands and on the net between basins)</p> <p>The long term sedimentation issue is not a single source issue. One issue that seems fairly prevalent is the filling of lots adjacent to the stream. Lot owners attempt to level out their land by removing the gentle slope leading to the stream bed hoping this will halt the meandering tendencies of a natural stream. Change can only be accomplished through an vigorous public education campaign.</p> <p>A couple of options not often discussed but ones that may have a some success on this site would be Hypolimnetic Aeration and Artificial Circulation. The installation of an aeration system would increase oxygen levels, increase the die off of rate of bacteria, and increase the mixing rate to control algae and spread the algae biomass. Hypolimnetic aeration can help reduce the release of phosphorus from sediment and can help increase oxygen levels in the sediments.</p>

This photo shows the settling basins and the end of Beaver Dam Brook. The large body of water on the bottom right is Fiske Pond. The larger rectangular basin is High Priority site # BB-NA 6. Note the trash net and the accumulated trash between bottom basin and Fiske Pond.

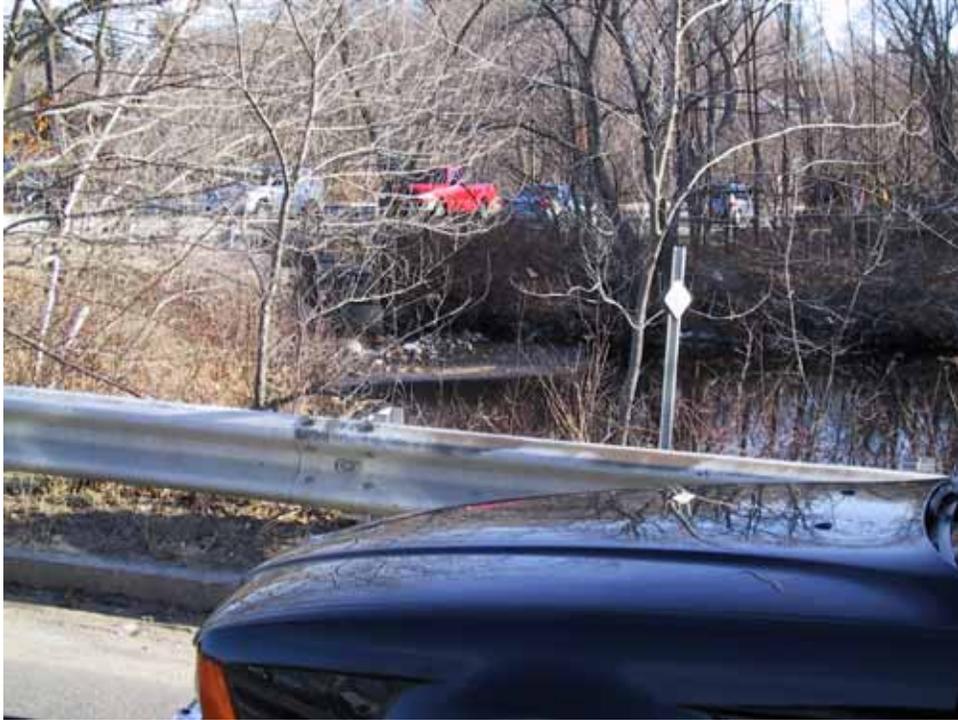
Note the trash net and the accumulated trash, under the red truck (same trash rack as previous aerial photo)

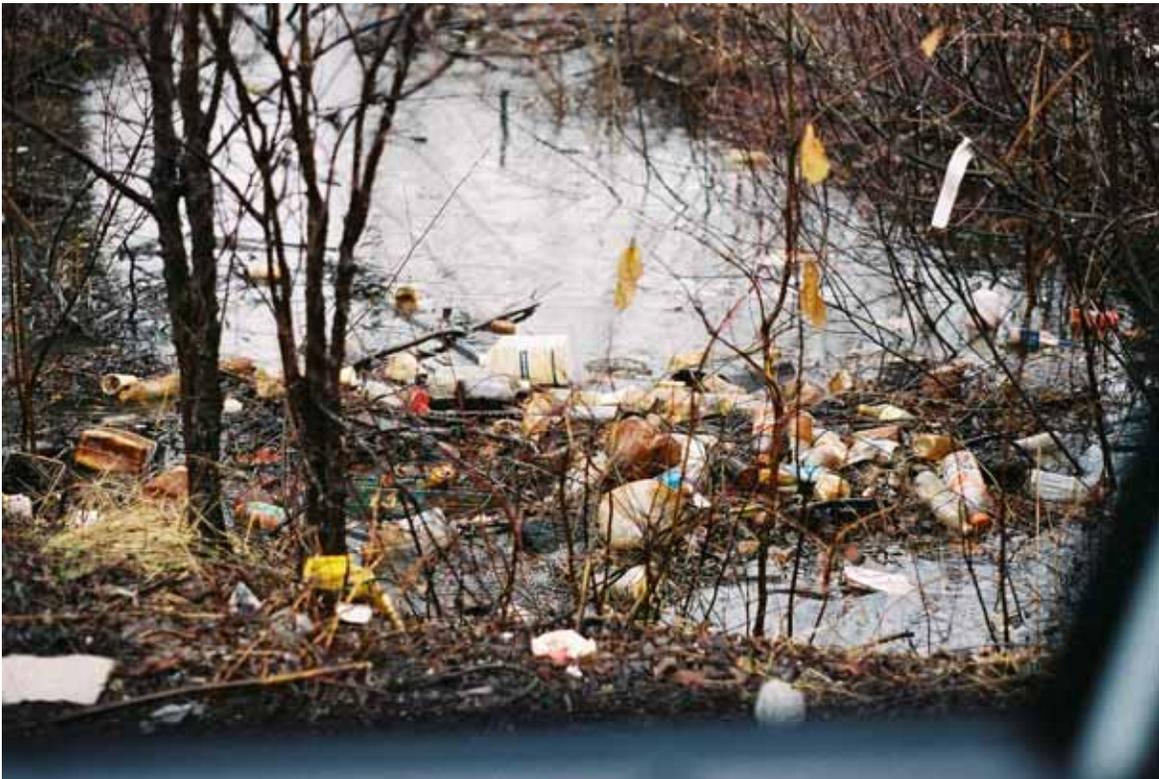
Photo shows a small pocket wetland flowing to Beaver Dam Brook and the need for a concerted effort to clean the end of outfalls.

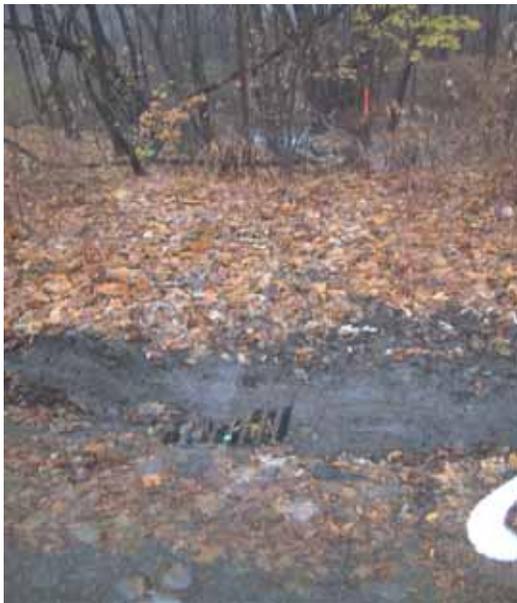
LAKE COCHITUATE PRIORITY SUB-WATERSHED ASSESSMENT AREA 3: Pegan Brook Sub-watershed	
SITE PB-NA-1	Failing catch basin and outfall
Location	Lake Street and LaGrange
Site Description	1 Lake Street floods after storm events due to poor catch basin design 2 Additional sedimentation at the outfall due to no rip rap
Problem	1 As a result of the failed catch basins lots of mud forms and siltation is easily discharged to the reduced capacity catch basin. 2 As the stormwater discharge exits the outfall pipe velocity stirs up the sediments and a muddy plume heads down stream
Recommended Actions / BMP's	1 Add a deep sump catch basin to hold sediments before discharge to stream 2 Add rip rap at the outfall discharge point to trap and slow effluent 3 Add a small asphalt berm to direct flows toward catch basin and to keep vehicles on the pavement Estimated cost of these measures, \$15,000

Catch basin set very low and seems to be quite small, presently filled with mud. New houses are being built in a lot down the street, trucks coming and going from the site are contributing mightily to the sediment load.

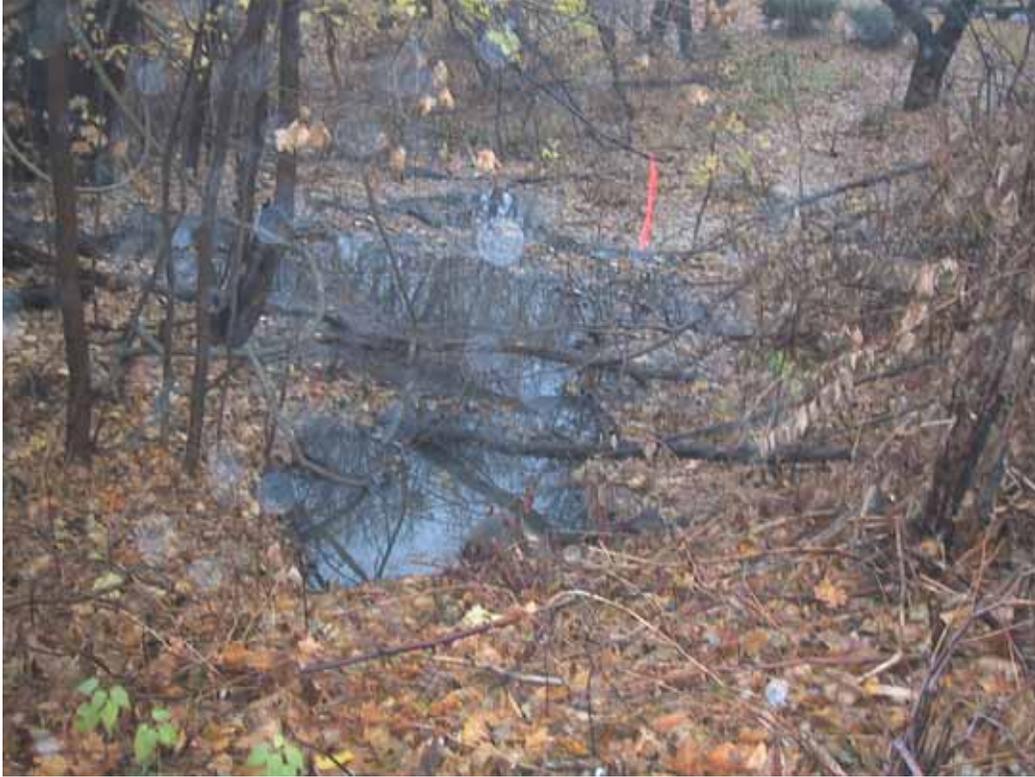
The outfall from the adjacent catchbasin discharges silt and mud from the street. The receiving pool is filled with a muddy plume leading to the mouth of Pegan Brook.

The outfall is located at the bottom of this picture. This pool leads to the mouth of Pegan Brook and runs parallel to Pegan Cove.

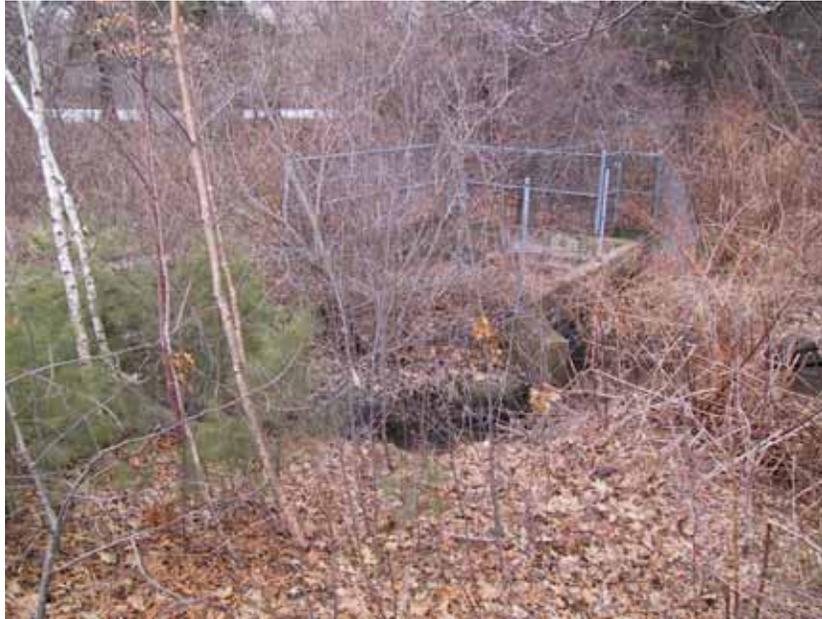
This photo shows the lake in the background, the non-upkeep of the structure, and the main flow of Pegan Brook by-passing and moving to the left of the structure.

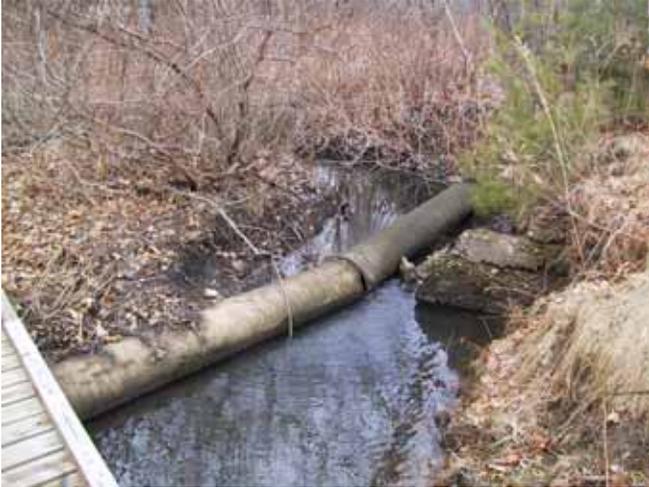
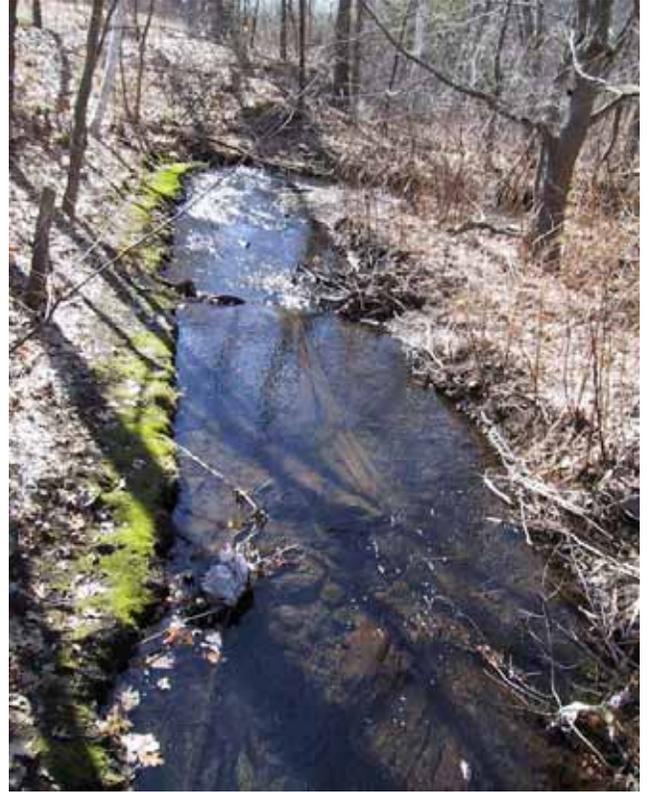
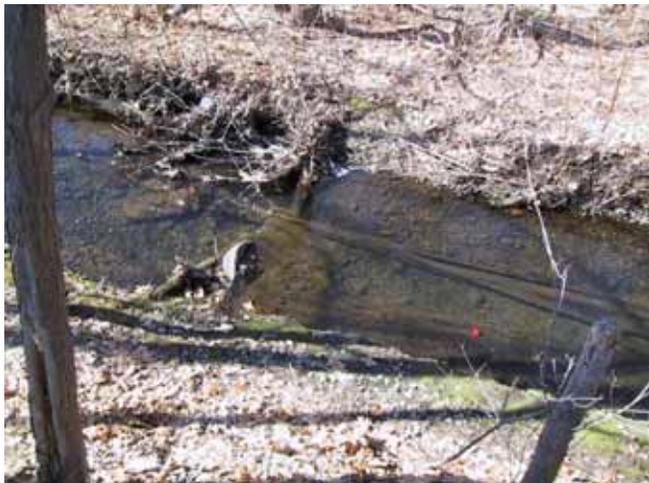
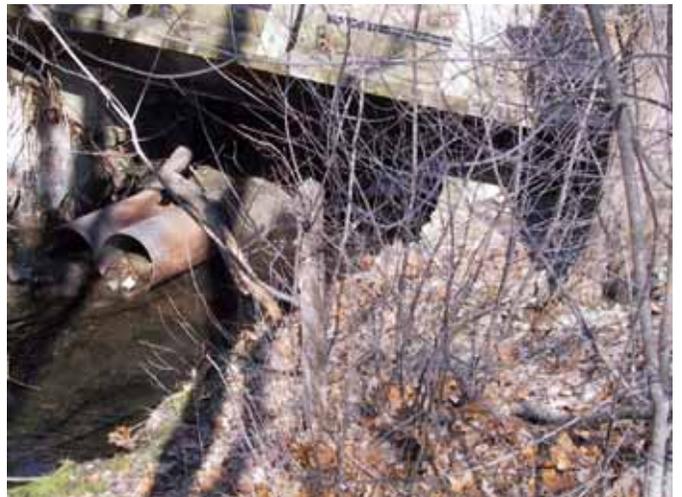
This page of photos show long lengths of filter fabric and pipes from different projects over the years. These are a few of several sections of the brook that have old building materials left behind.

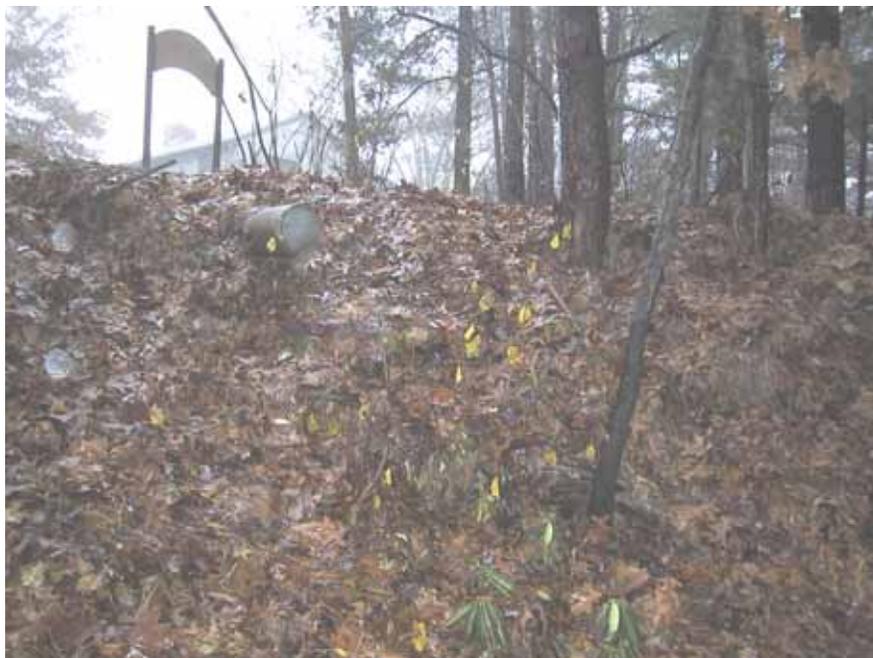
Some of the phosphate issue in Lake Cochituate is potentially from yard waste disposal into the wetland system. The photo below is an example of heavy yard waste disposal into an area just above the Pegan Cove park wetland system.

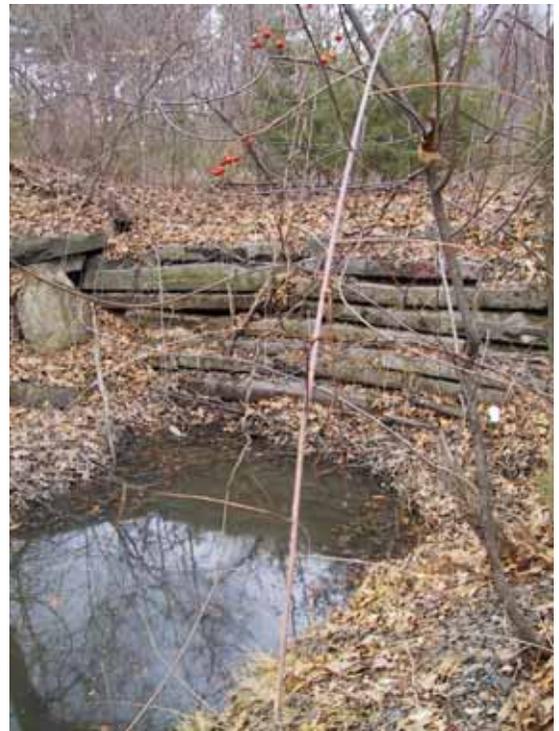
Watercourse on the South side of the RR tracks.
Water ponds due to elevations and blockage by debris

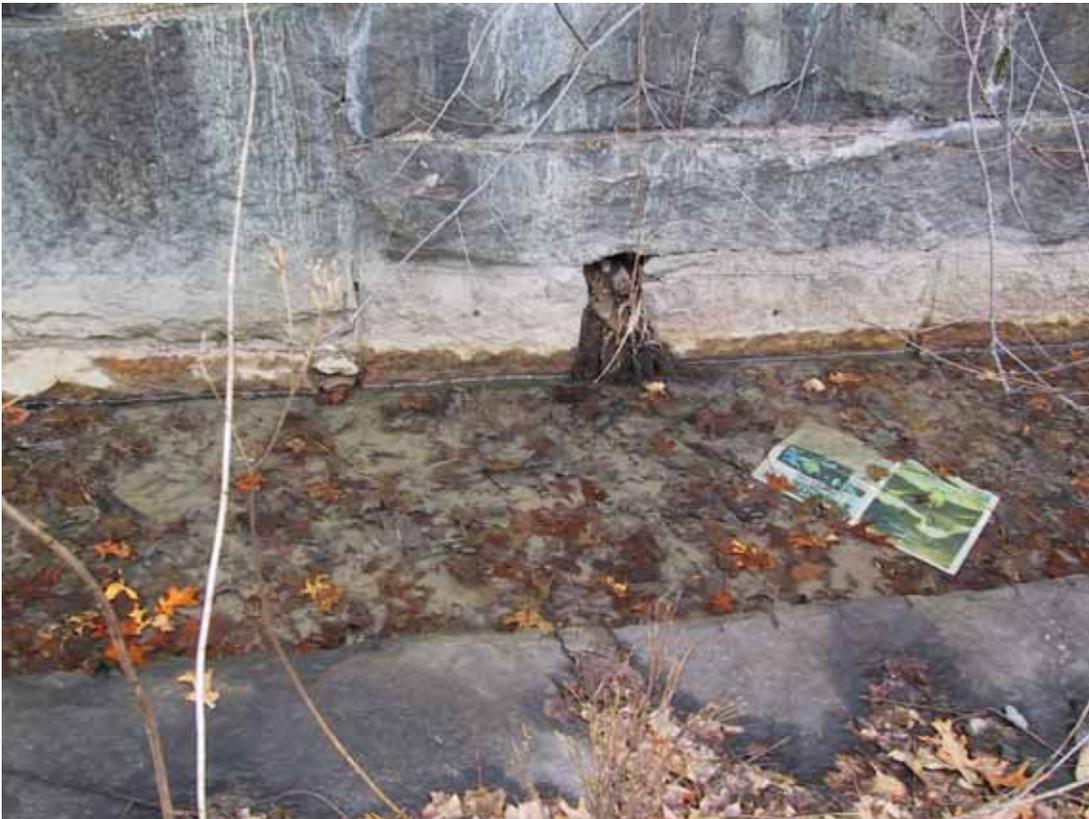
LAKE COCHITUATE PRIORITY SUB-WATERSHED ASSESSMENT AREA 3: Pegan Brook Sub-watershed	
SITE PB-NA-5	Duraelectric site on North Avenue
Location	61 North Avenue
Site Description	Industrial site sitting adjacent to the channelized portion of Pegan Brook (north side of RR tracks) Building sits above the RR tracks and Pegan Brook atop a large retaining wall constructed of granite blocks
Problem	Stream channel runs parallel to the property site, on March 3, 2004 heat was emulating from the bottom of the retaining wall. A large amount of algae is presently growing in the section of stream along this property, none above or below property. Some type of sedimentation is also coming out of the wall's bottom. This sedimentation from this site is proceeding to the point where the stream is culverted by the Natick Commuter rail station
Recommended Actions / BMP's	<ol style="list-style-type: none"> 1 Site needs further investigation and possible enforcement 2 Check on the source of the heat source affecting the brook 3 Check on the source and make up of streambed sedimentation

Note the sedimentation on the channelized stream bottom and the stained wall. Sedimentation is not found upstream of this site (see next photos).

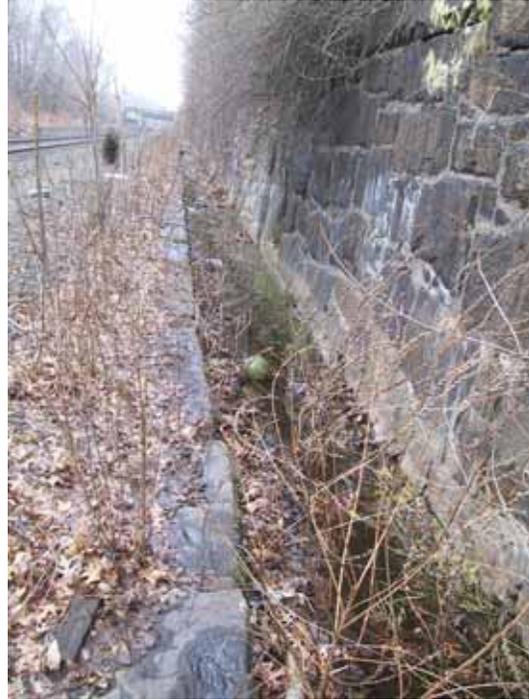
Down stream view (siltation)

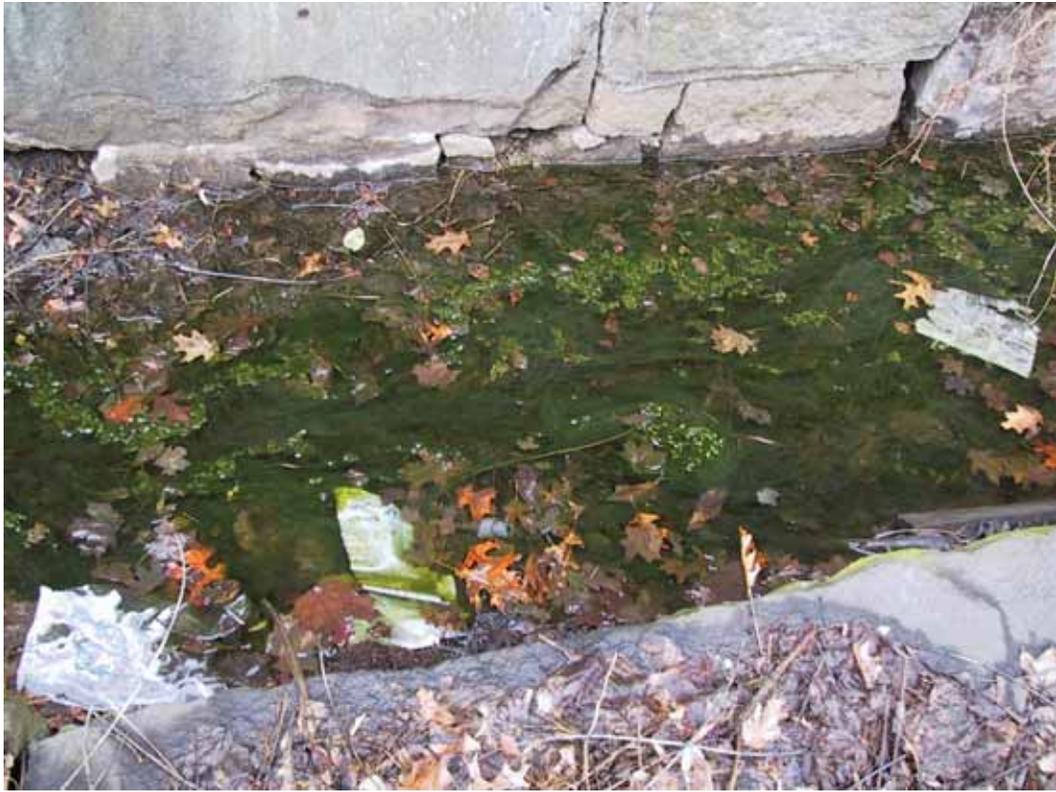
This photo shows algae growing while the outside temperature is in the mid 30'

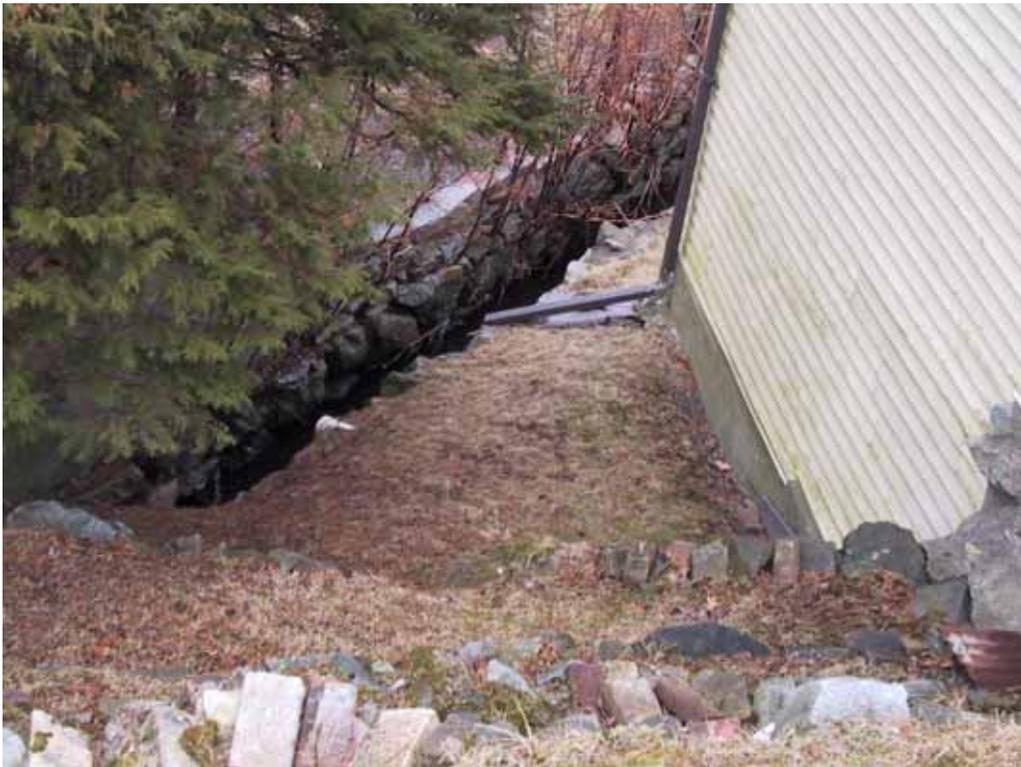
Note the downspout and the white drainage pipe draining directly to the stream

Recommended Actions / BMP's:	<ul style="list-style-type: none"> • Constructed wetland with a forebay to handle flows from the culverted flows south of the RR tracks (estimated cost, \$75,000) • Storm drain inserts to capture sediments and trash before dropping to the culvert cost approximately \$300-\$400 per unit x 8- 10 units • House run-off over grass filter strip before straight entrance to stream or a rain barrel for alternative water usage, this would require realigning the gutters on the house pictured below cost about \$300
