# MALDEN Climate Resiliency Planning

*City Parks Resiliency Assessment  
and Recommendations*

PREPARED FOR:  
**City of Malden**

PREPARED BY:  
**Shadley Associates P.C.**

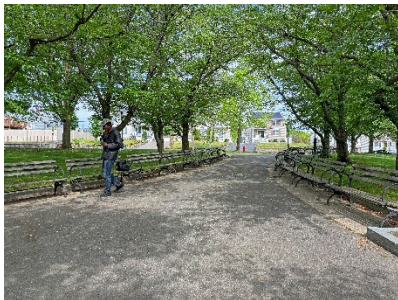
*Southern portion of park*

Several trees in the southern portion of the park are in poor health, and an additional tree in poor condition currently overhangs the playground. These trees should be removed and replaced as they may become a public safety hazard during high wind events. On the northwest corner of the playground, there is a patch of invasive Japanese Knotweed that the city should address immediately. Japanese Knotweed is an aggressive invasive species that is difficult to eradicate once established.

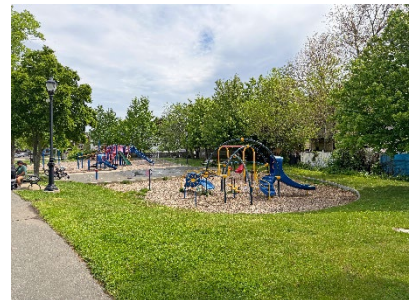
While the walkways within Lincoln Commons provide accessible routes to all portions of the park, the engineered wood fiber safety surfacing within the playground has settled, resulting in no accessible route into the playground itself. Within the playground, due to the depleted elevation of the wood fiber surfacing, it appears that the equipment transfer modules are no longer in compliance, and the existing equipment is deteriorating. Companion spaces for wheelchairs are provided at benches around the playground, but similar shaded seating areas are lacking at the southern end of the site where there is greater shade coverage and more seating opportunities. The park also lacks bicycle parking, which may discourage residents from biking to and within the park. Lincoln Commons is in an English isolation neighborhood meaning 25% or more of households in this area lack an adult over the age of 14 who reports speaking English “very well”. However, all signage within the park is currently in English with no translated information available to residents. The presence of site lighting along the park walkways is valuable for security and improves safety during nighttime hours.

*Playground*

**Renovate Playground:** The existing playground at Lincoln Commons is not fully accessible due to settlement and displacement of the engineered wood fiber surfacing. According to community outreach completed in 2024, Lincoln Commons playground is the third most popular playground in Malden. It is recommended that the City renovate the playground and install an accessible safety surface, such as poured-in-place rubber, to ensure accessibility for all users. It would also be advantageous to replace some or all of the existing play equipment as part of the surfacing renovation project. The equipment is dated and exhibits signs of wear and deterioration.

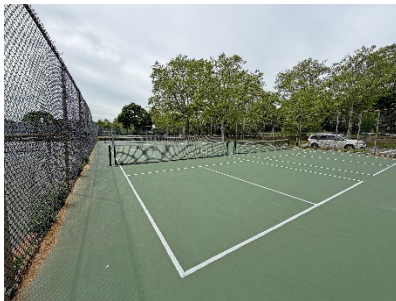
Improvements to install new pickleball courts and repair cracks in the courts were completed in 2023. However, accessibility concerns, deteriorating site furnishings, limited vegetative cover, and the lack of green infrastructure present opportunities for resiliency improvements at Amerige Park.

*Pickleball courts*

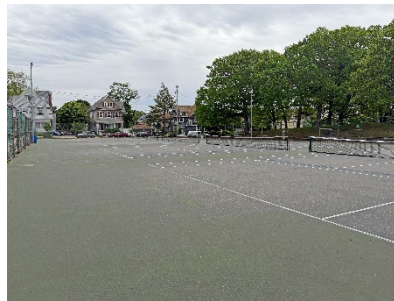
*Tennis courts*

**Provide Seating Throughout the Park:** Amerige Park and its courts lack adequate seating for park users and spectators. Of the eight benches within the park, two are located within the tennis court and are not accessible due to their seat height. These benches are also damaged and deteriorating. The remaining six benches within the park are concentrated near the Fellsway entrance and playground, with all six located within approximately 150 feet of one another. While seating around playgrounds is important, additional seating should be provided throughout the park. The installation of a loop walk around the perimeter of the park would provide numerous opportunities to incorporate seating at strategic locations.

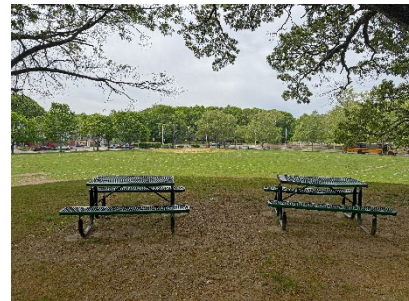
*Picnic tables on grassy knoll*

The existing stand of mature oaks on the grassy knoll at Amerige Park provides excellent shade for portions of the tennis courts and the picnic tables located on the knoll. However, these trees are in need of pruning, as multiple dead limbs within their canopies may become public safety hazards.

**Install Accessible Walkways Throughout Park:** It is recommended that the existing fields be reconfigured to incorporate an accessible loop path and connections to the soccer fields. Renovations to the fields would be beneficial to the community as they are currently heavily used by multiple organizations including Malden High School, Malden Youth Soccer, Malden Thrashers, and Malden Catholic High School. There is currently no accessible route providing access to the southern half of the park. In addition, there is no accessible route to the picnic tables located atop the grassy knoll.
