MAPC Accessibility Issues

I. OVERVIEW

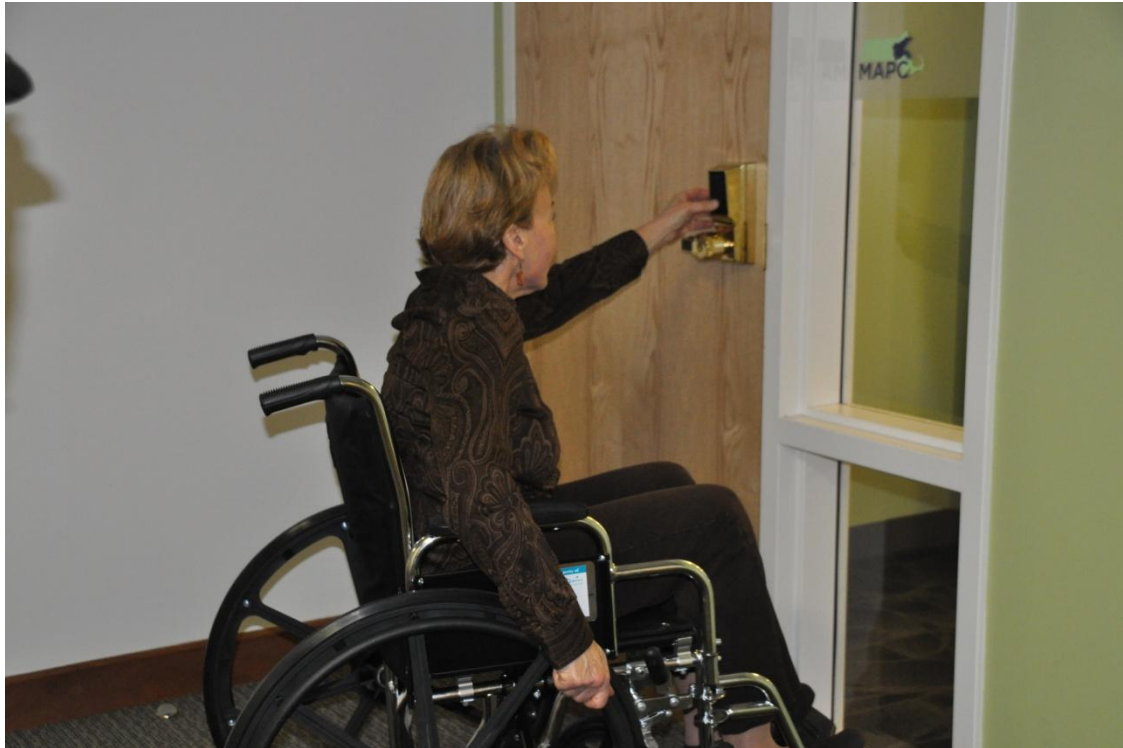
On the third and fifth floors we have a number of keypads that require using an access code to get through a door or to use the restroom. The standard for door handles is that they must be able to be opened using only one hand, held in a fist. This is because a person who has limited use of his or her hands may only be able to use a fist. This standard is also used for controls such as electrical controls, mechanical controls or self-service controls. The key pads cannot be easily opened by someone with a closed fist. The small buttons and close spacing would be impossible to operate without fingers or at least knuckles. Some of these keypads provide access to restricted areas such as our conference room and would only be an issue if we had a staff person with a disability. Others, such as those for the restrooms, would be used by the general public.

Figure 1
The access key pads require the use of your fingers

- Bring this to the attention of the building management and ask them to research alternatives that may be more accessible. If these exist, they should be installed on all restroom doors.

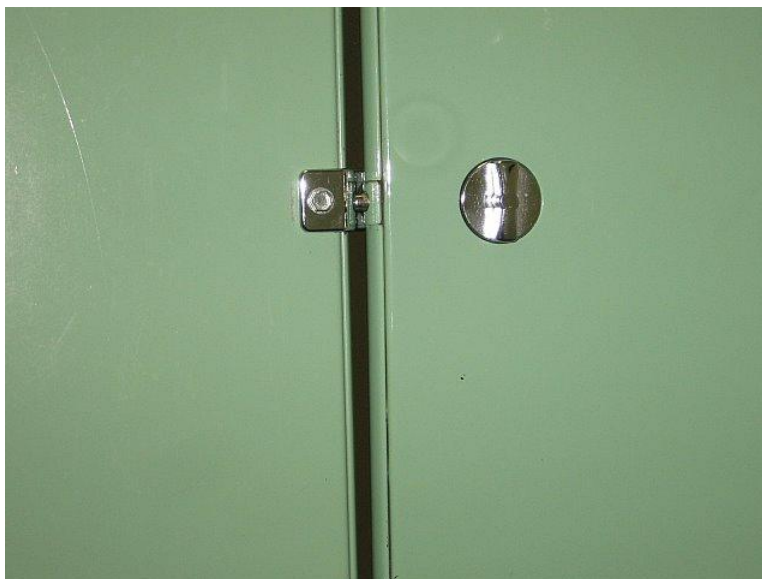
The standard for door handles is that they must be able to be opened using only one hand, held in a fist. This is because a person who has limited use of his or her hands may only be able to use a fist. Generally this is accomplished by using lever handles rather than knobs. All of our office doors have levers but the one place where this is not done is in the restroom stalls. All of the restroom stalls are opened and closed using small round knobs that have a small raised strip in the middle. This makes it very difficult to open or close with a closed fist.

Figure 2:
This knob on the handicapped stall cannot be opened with a closed fist

- Replace all the hardware in the accessible stalls with levers.

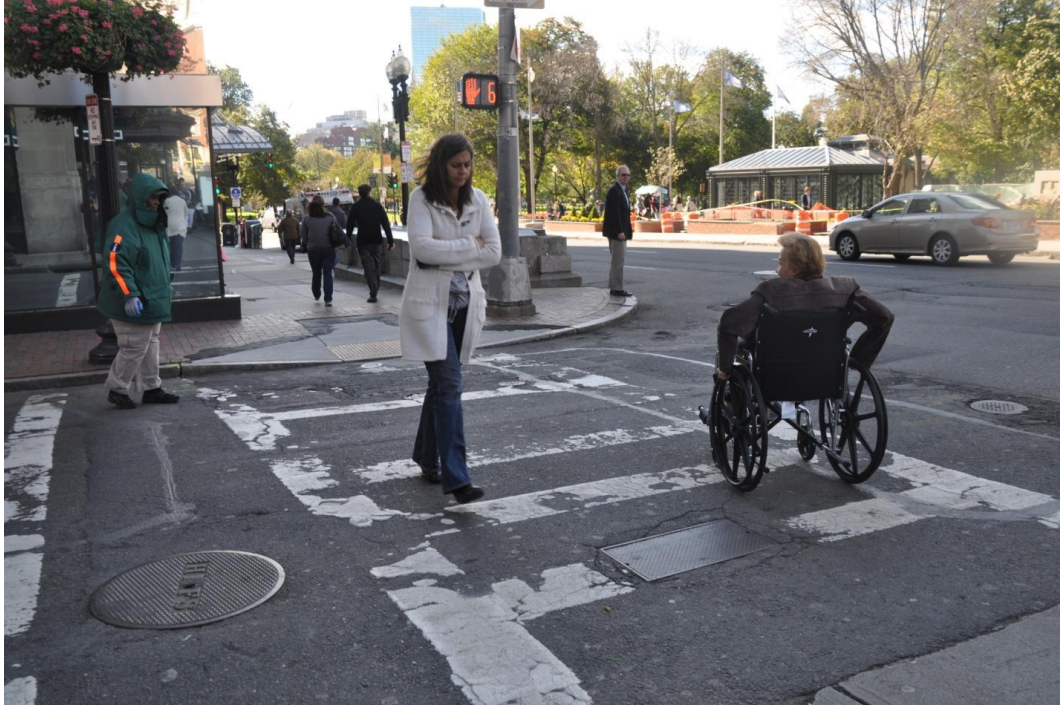
Figure 3:
Typical street and sidewalk conditions

Temple Place has curb cuts at every intersection and the sidewalks are in relatively good condition.

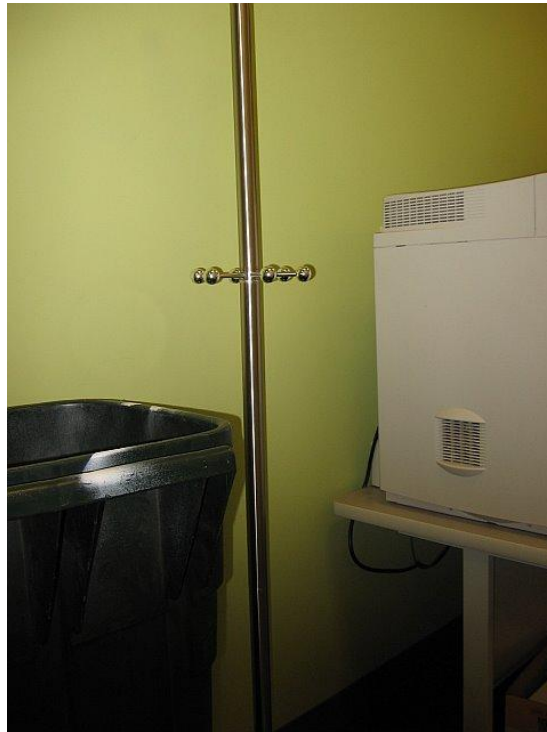
Figure 4:
This coat rack can be used by someone in a wheelchair

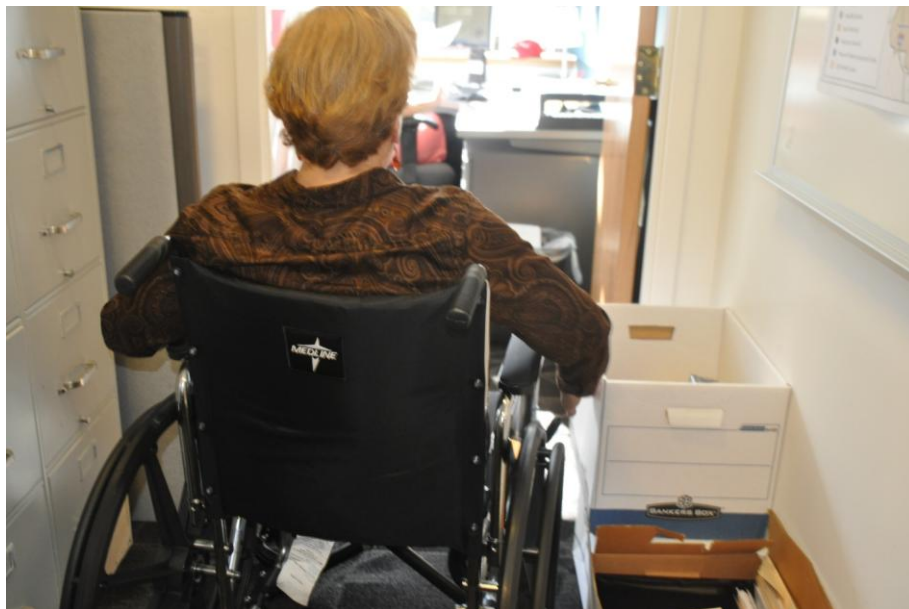
Figure 6:
Boxes in the hallway narrow the aisle

- Have staff undertake general housekeeping to relocate boxes that are stored in the hallways.

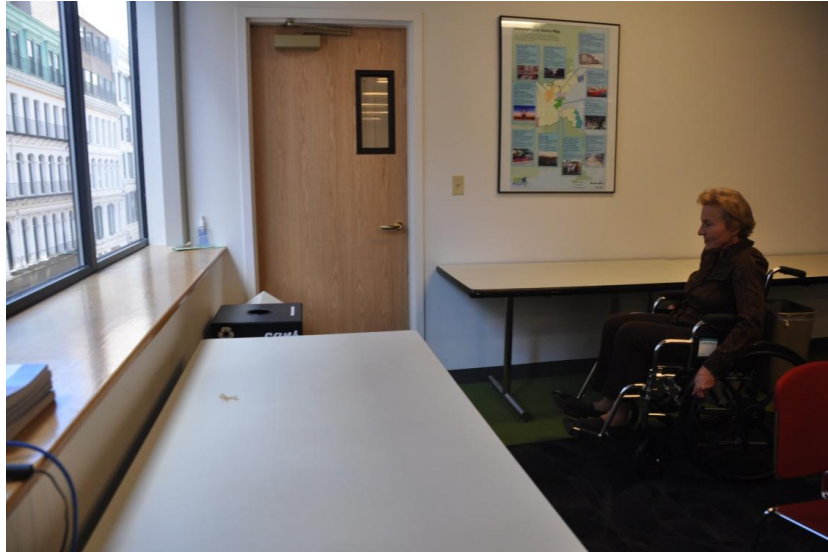
Figure 7:

When trying to turn into the kitchen the placement of a trash can and recyclables bin made it impossible to get between the two tables and turn into the kitchen. These items had to be moved in order to get into the kitchen. Inside the kitchen there is a step stool that is stored on the right side of the door. This also narrowed the aisle and made it difficult to maneuver. I was able to reach the coffee maker, the microwave, the paper towels and the refrigerator. There is a slanted panel under the sink but it is not deep enough to allow easy access to the sink faucet and the soap dispenser. The telephone is on a table at a convenient height.

Trash cans and the placement of the tables makes it difficult to get into the kitchen

- Relocate the trash can and recyclable bin away from the entrance to the kitchen.
- Move the two tables farther apart to ensure that there is 36 inches between them.
- Move the step stool away from the kitchen door.
- Remove the panel under the sink so that a wheelchair can be placed closer to the sink.

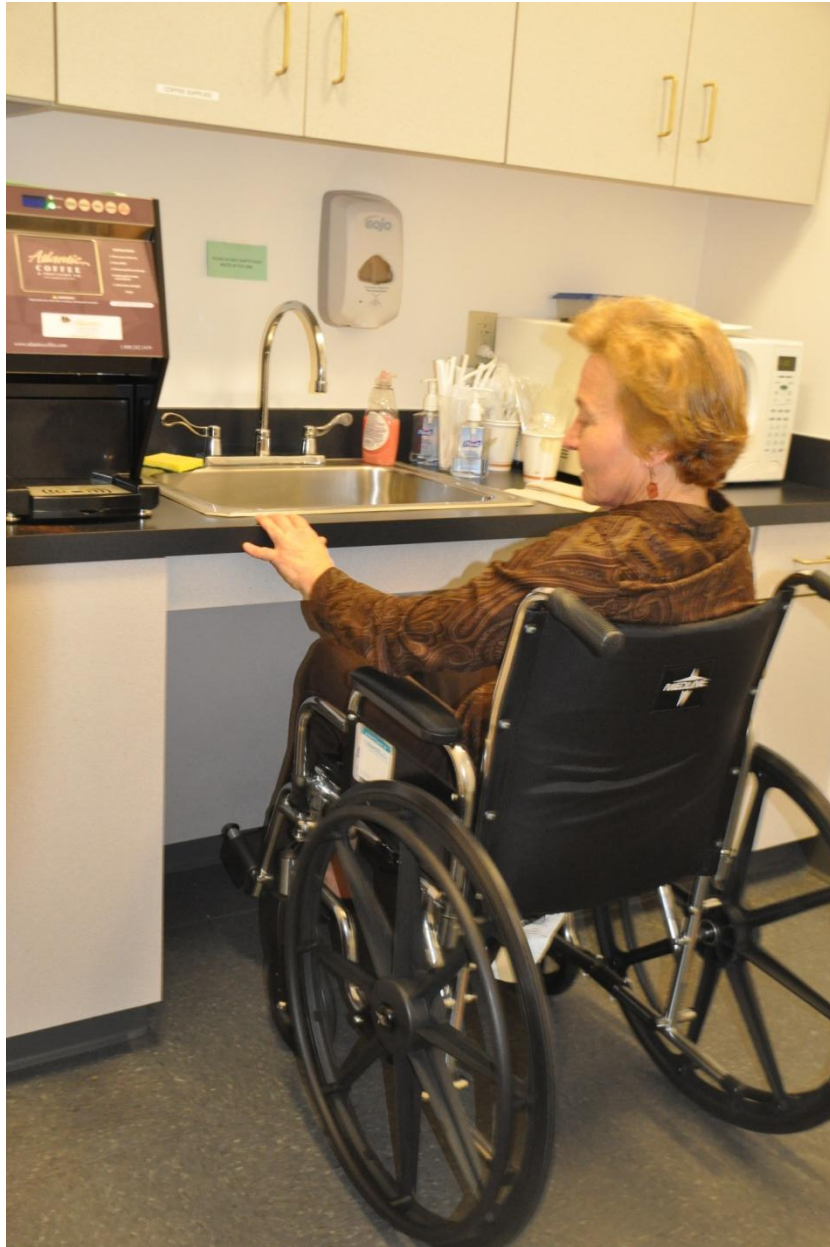
Figure 8:
There is not enough space to pull up close to the sink

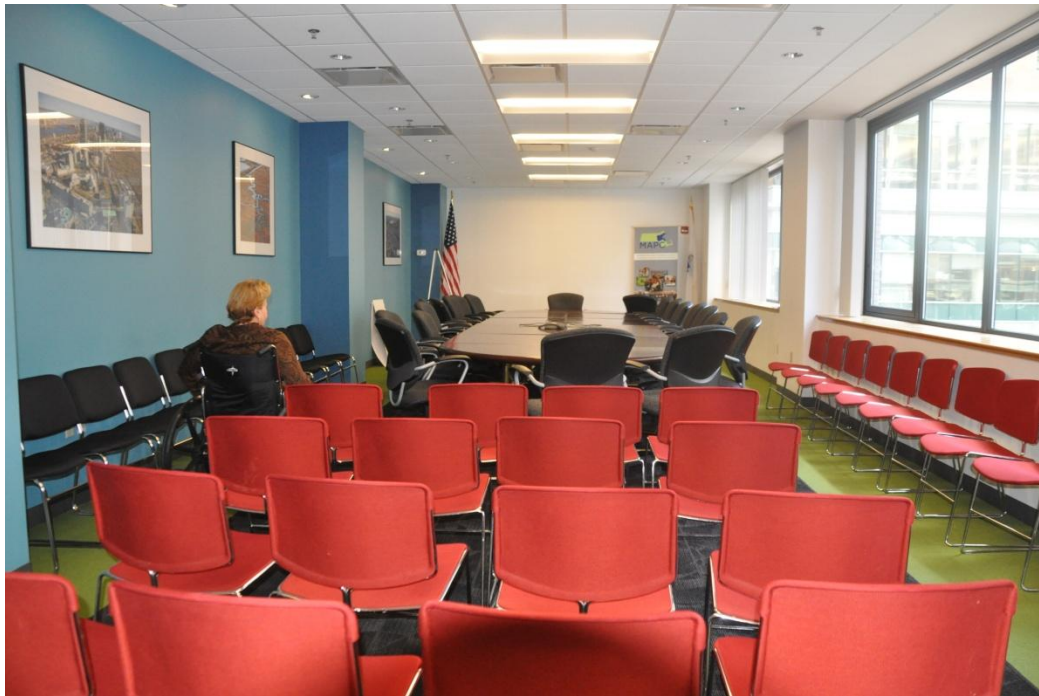
I had no trouble getting into the conference room. I was able to reach the light switch. The coat rack was reachable but not easily. The placement of the red chairs did not allow enough space to reach the table without moving several. There is not enough clearance on either side of the table to go to

Figure 9:
The seating makes it difficult to get to the conference room table

- Reconfigure the bank of red chairs so that there is a 36 inch wide aisle left clear from the entrance to the table as an accessible path of travel.
- Delineate one 36 by 60 inch wide space for a wheelchair and provide a sign indicating that this is reserved for wheelchairs.
- Add one accessible coat rack.

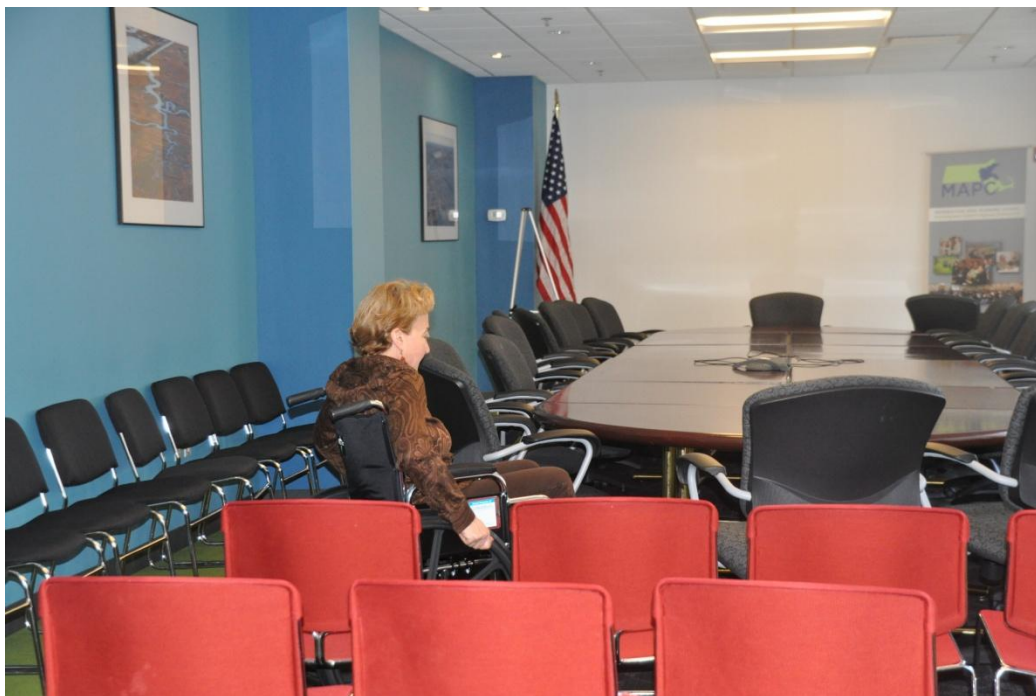
Figure 10:
Too many chairs creates difficulty getting to the table

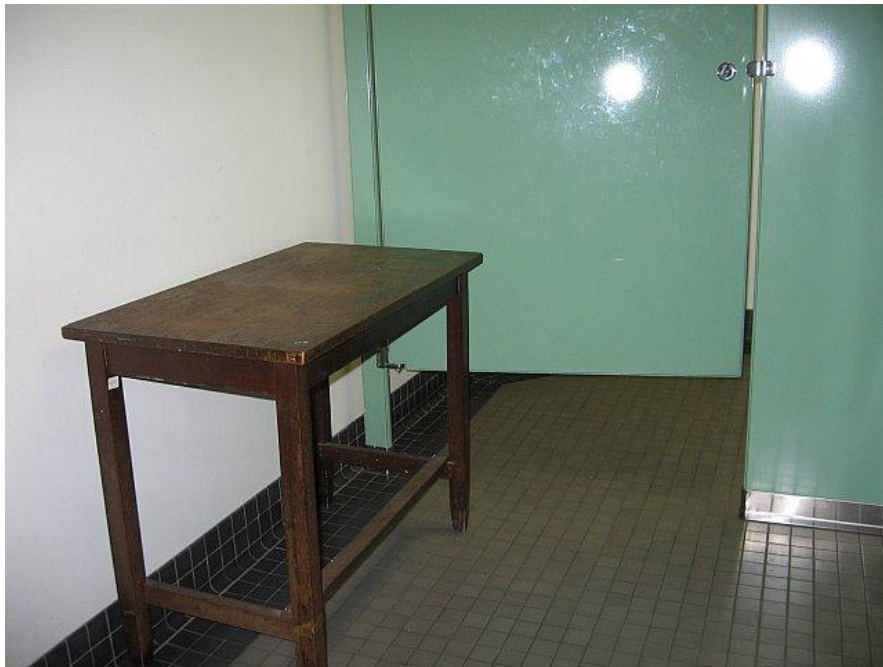
The door handle inside the accessible stall is a small, round knob that is more or less flush with the door and not easily opened with a closed fist. The threshold at the door may exceed the standards and presented an obstacle. The wooden table creates an obstruction by narrowing the path of travel to 26 inches wide. The paper towel dispenser top is 52 inches high and the rim of the waste receptacle is 41 inches high. The door handle to the bathroom door is 37 inches high but requires almost 9 pounds of pressure to open. Because this is not a public rest room, there is no key pad.

Figure 11:
This table blocks access to the handicapped stall

- Remove the wooden table.
- Install lever handles on handicapped stall doors.
- Test and recalibrate the self-closing hinge.

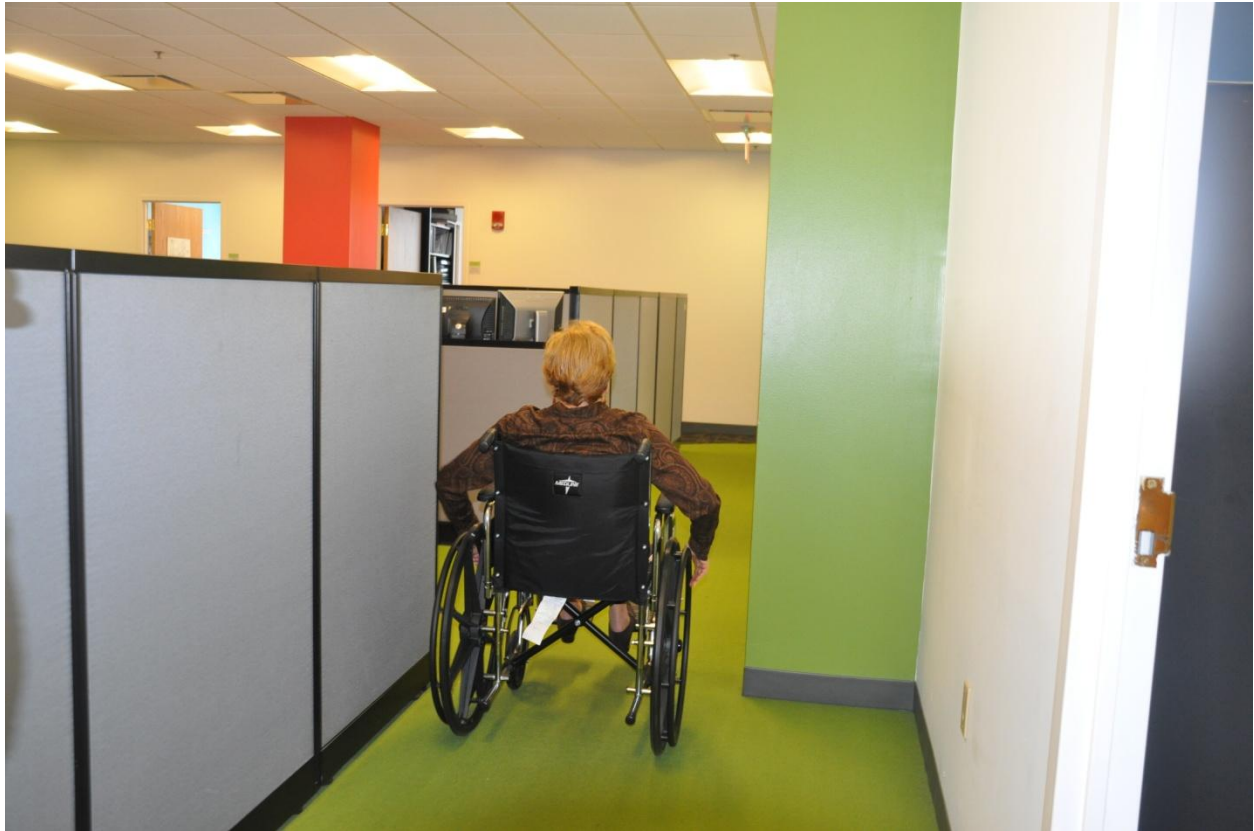
In general, the hallways are wide enough to accommodate a wheelchair and all areas were accessible for straight-ahead travel. The location of file cabinets or equipment immediately opposite an office door made it difficult, although generally not impossible, to turn into an office. The carpet is smooth and was not a problem.

Figure 12:
The office hallways provide the required 36 inches of width

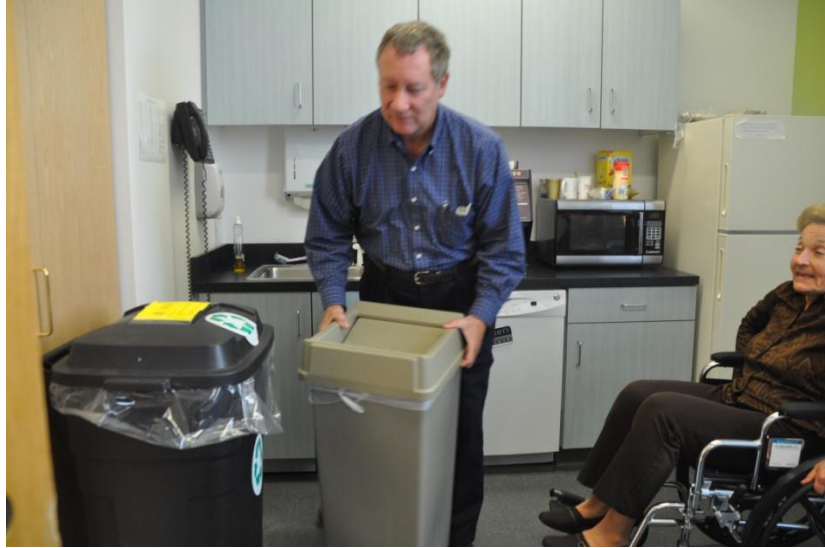
The sixth floor kitchen is a heavily used space. The automatic light sensor does not work. The water cooler and counter top height is 34 inches. In order to get under the sink, one would have to open the cabinet doors and push aside the many cleaning items that are stored there. The coffee machine and microwave are reachable although coffee supplies may be out of reach. There is a trash can and recyclables bin that block access to the sink.

Figure 13:
It was necessary to move the trash cans to get to the sink

- Remove the doors under the sink and relocate stored items.
- Lower the telephone.
- Relocate the trash can and recyclable bin.

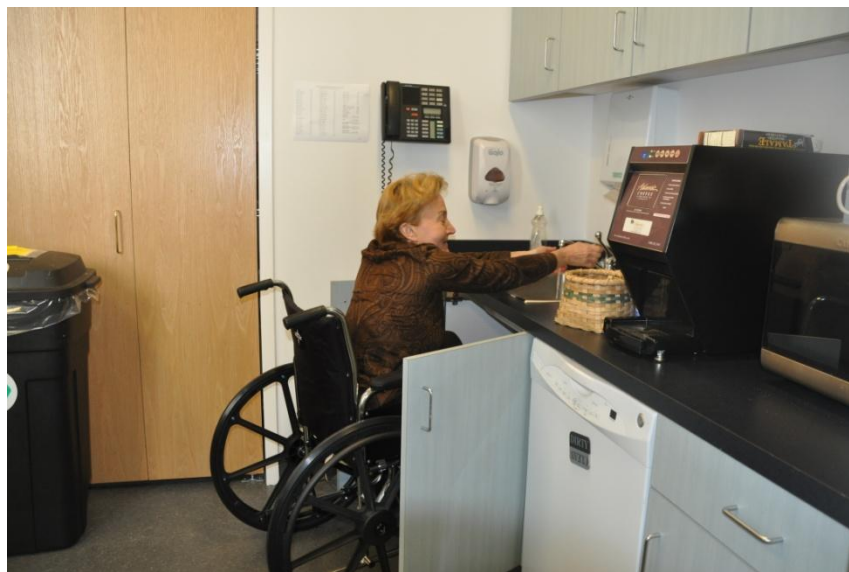
Figure 14:
Removing the cabinet doors would make it easier to reach the sink

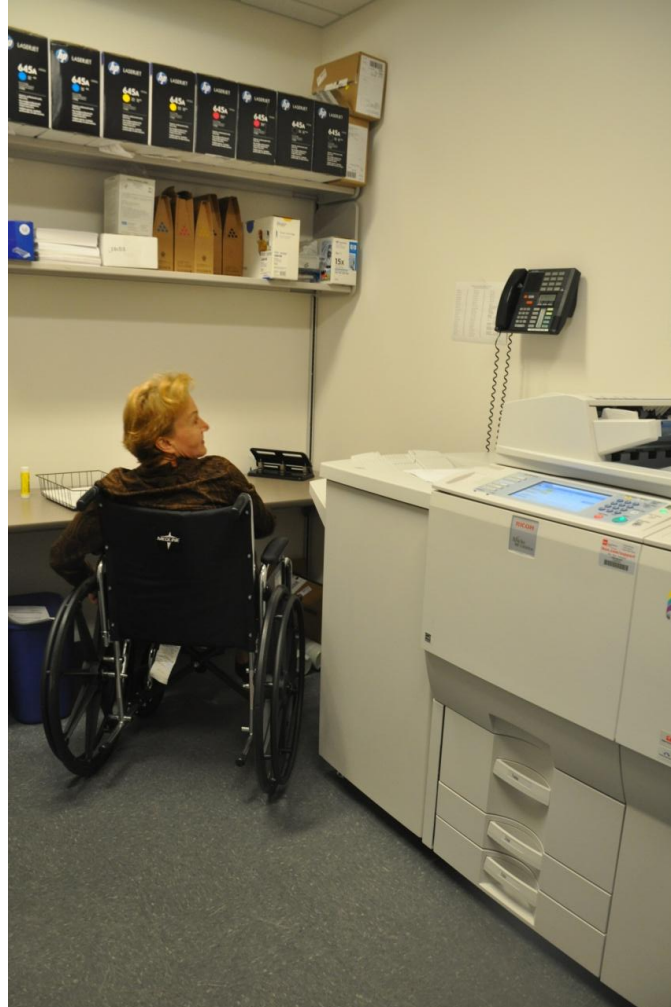
At 44 inches, the aisle between the two copy machines is adequate but there is no turn around room at the end. The controls on the large copier would be difficult to reach. The far counter is 30 inches high and accessible. The supply and machine counter is 37 inches high with 42 inches of space underneath. Some of the equipment on that counter may be difficult to reach. The telephone is 56 inches high and only 17 inches of space to get to it.

Figure 15:
The telephone is not accessible from a wheelchair

- Move the phone to another location and if wall-mounted, lower it. It could also be placed on a counter.
