# **Lake Cochituate Nonpoint Source Pollution Watershed Management Plan**

# Lake Cochituate Nonpoint Source Pollution Watershed Management Plan

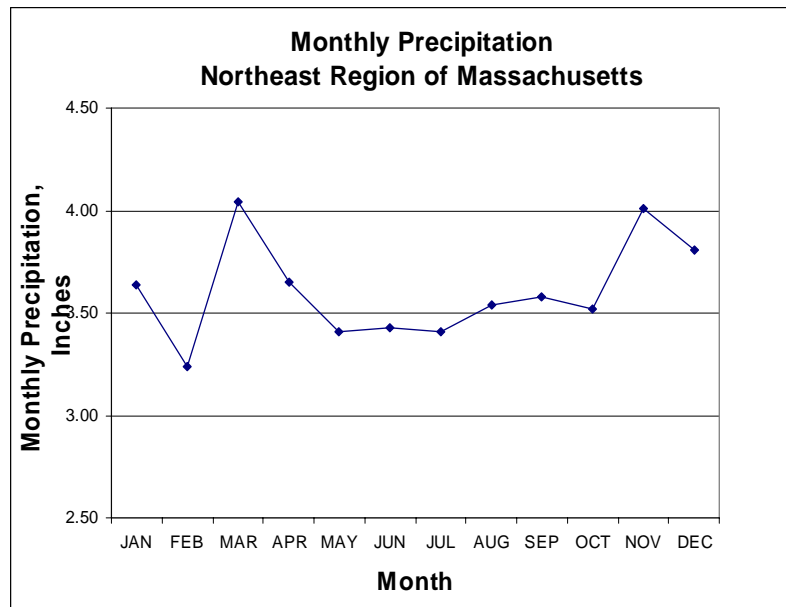
**Figure 2-2 Average Monthly Precipitation in the Northeast Region of Massachusetts**

Month	Northeast
JAN	3.64
FEB	3.24
MAR	4.04
APR	3.65
MAY	3.41
JUN	3.43
JUL	3.41
AUG	3.54
SEP	3.58
OCT	3.52
NOV	4.01
DEC	3.81
<b>ANNUAL</b>	<b>43.28</b>

Average annual precipitation in the northeast region of Massachusetts is 43.28 inches (see Table 2-2). Precipitation is distributed fairly evenly over most of the year, at about 3.5 inches per month for most months, with an increase to 4 inches in the months of March and November. This precipitation pattern suggests that stormwater would be generated relatively evenly over the year, however because of freezing conditions in the winter months, there is normally reduced runoff in the winter as most precipitation is stored in the form of ice and snow. This typically leads to annual peak stormwater runoff rates in the early spring, when melting ice and snow combines with spring rainfall.

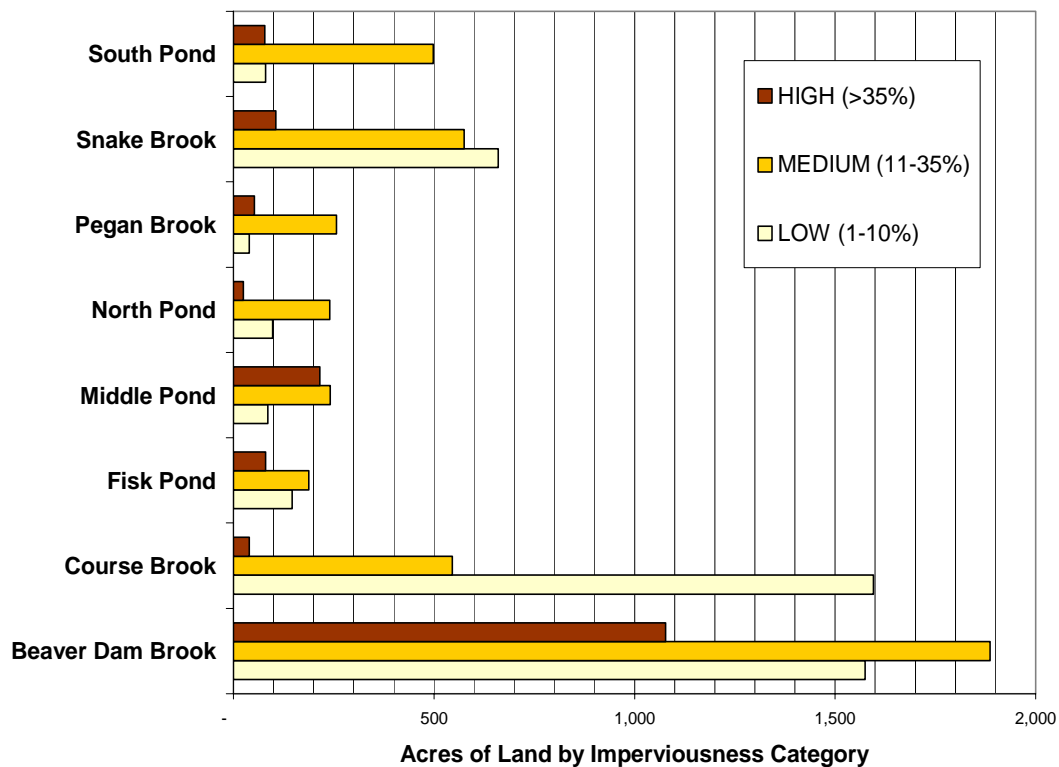
**Figure 3-5 Watershed Imperviousness by Subwatershed (Acres)**

Subwatershed	LOW (1 - 10 %)	MEDIUM (11 - 35 %)	HIGH ( > 35 %)
Beaver Dam Brook	1,575	1,886	1,077
Course Brook	1,596	546	40
Fisk Pond	146	188	80
Middle Pond	86	241	215
North Pond	98	241	25
Pegan Brook	40	257	53
Snake Brook	660	575	105
South Pond	80	498	78
<b>Lake Cochituate Total</b>	<b>4,281</b>	<b>4,432</b>	<b>1,673</b>

The data above portrays the imperviousness of the entire Lake Cochituate Watershed, but the degree of imperviousness varies greatly across the eight subwatersheds (see Table 3-10 and Figure 3-5). The greatest area of combined medium and high impervious land uses, nearly 3,000 acres, is in the Beaver Dam Brook watershed, while the highest percentage of medium and high impervious land, 89 percent, is in the Pegan Brook subwatershed, and at 88 percent, the South Pond subwatershed. These are extremely high levels of imperviousness.

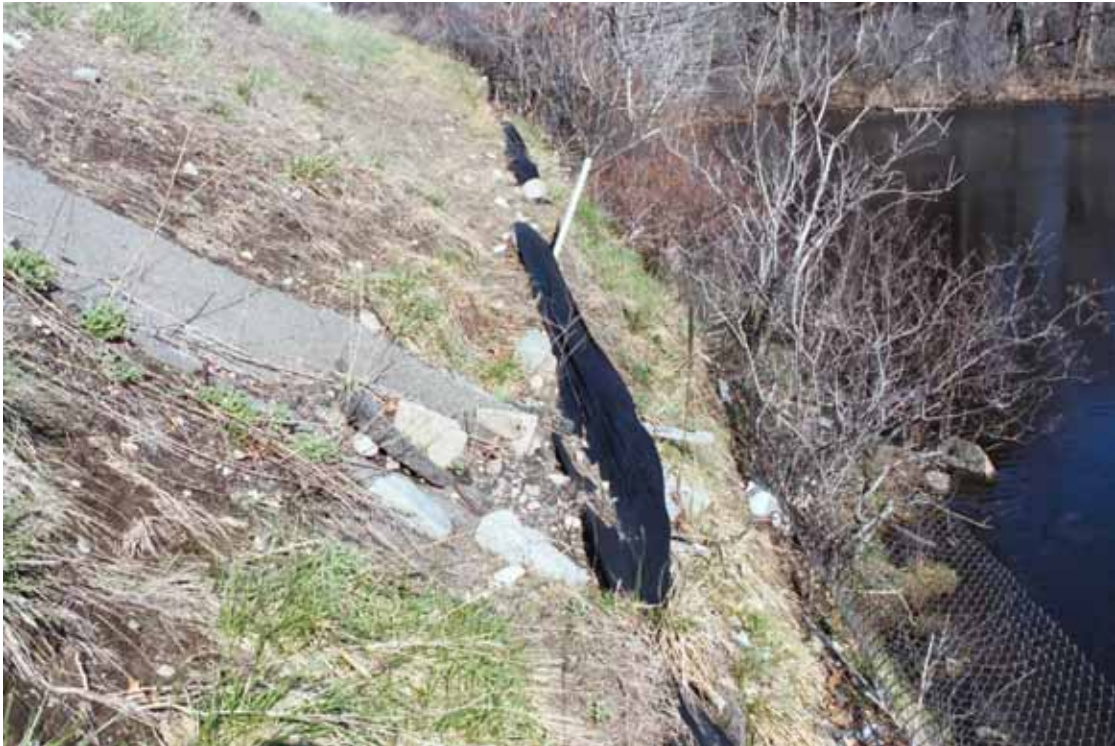
**Figure 4-4 Unstable Turnpike Embankment on Middle Pond**

Stormwater runoff from an approximately ½ mile segment of the Mass. Turnpike discharges to North Pond from the westbound lanes and to Middle Pond from the eastbound lanes. All runoff from the Natick service plaza also discharges to Middle Pond through an open paved drainage swale. Further, the embankment for the eastbound lanes on the shore is Middle Pond is unstable and eroding (Figure 4-4).

*Recommendations for the Massachusetts Turnpike:* The Mass. Turnpike Authority should improve maintenance of the existing drainage system, and stabilize the eroding embankment on Middle Pond. The MTA should consider retrofitting the drainage system of the service plaza with BMP's to provide pre-treatment for sediments and oils, such as hydrodynamic separators. The estimated cost of these units is \$35,000 each, and two to four units would probably be need to handle runoff from this site. The MTA should also consider redesigning the existing drainage ditch to create a more functional vegetated retention area that could remove more of the pollutant load before stormwater is discharged to Middle Pond. Finally, the practice of dumping snow into the drainage ditch should be discontinued, as this increases the sediment load to the drainage system.

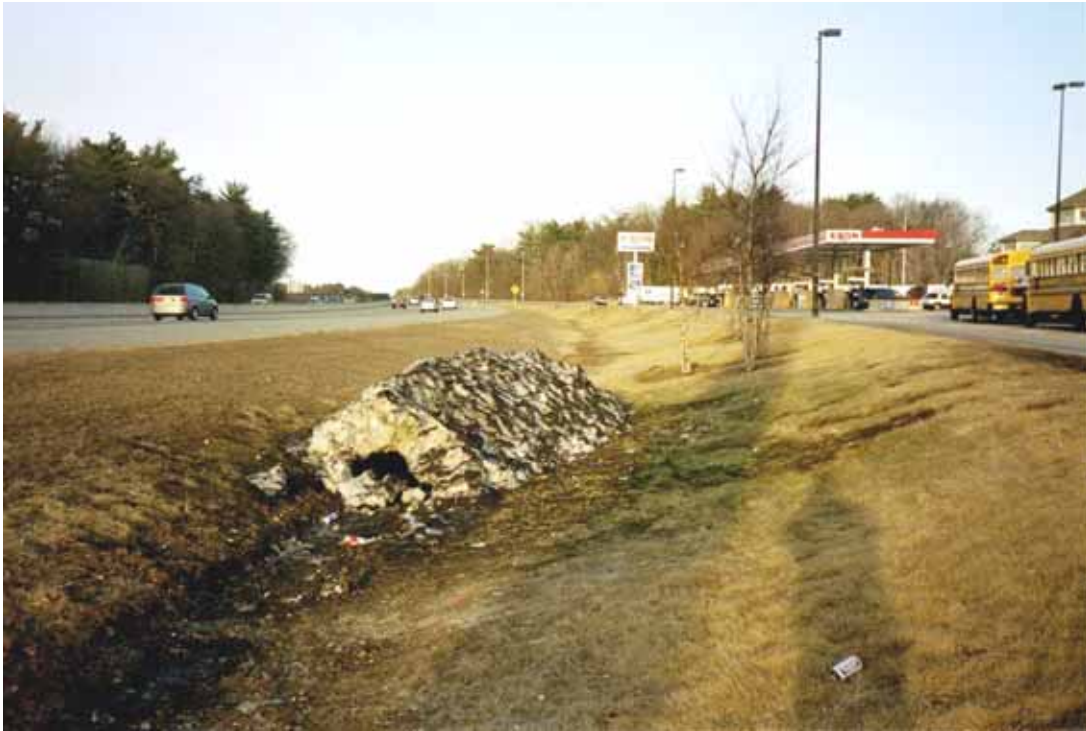
**Figure 4-8 Sediment laden snow pile in drainage ditch, Natick Service Plaza**

The Mass. Turnpike runoff discharges to Lake Cochituate with no pre-treatment to mitigate stormwater quality. This type of discharge would not be allowed under current DEP Stormwater Guidelines. The drainage system shows evidence of sedimentation and lack of maintenance. The drainage outlets from the service island to the drainage ditch are full of sediments (Figure 4-6). Runoff from the fueling area and truck stop is also a potential source of polluted runoff due to spills and leaks (Figure 4-7). Stockpiling of plowed snow was observed within the drainage ditch, and the snow contained considerable sediment load (Figure 4-8)
