5.0 WATERSHED ACTION PLAN FOR PRIORITY SUBBASINS

LAKE COCHITUATE PRIORITY SUB-WATERSHED ASSESSMENT	
AREA 1: North Pond Sub-watershed	
SITE NP-FR-1	Lakeview Road Drainage
Location	Lakeview Road, Framingham
Site Description	Lakeview Road is a residential street that runs along the shore of North Pond. Stormwater from this area is collected in a series of catch basins and discharged directly to North Pond through a series of four outfall pipes (see Map 9).
Issues/Problems	<p>1) Where Lakeview Road dead ends near the bank of North Pond, there are two catch basins that are not collecting the stormwater flow from the road because they are clogged. As a result of the failed catch basins, stormwater overtops the curb at the dead end of Lakeview Road and flows overland across the yard of the adjacent home, then rushes down the steep slope, causing significant erosion and sedimentation. The homeowner has a set of wooden stairs on the slope which show evidence of sediment deposition, and the roots of trees on the slope have been scoured and undercut by the stormwater flow. Framingham's drainage plan shows these 2 catch basins connected to the outfall southeast of the site. But it appears tha

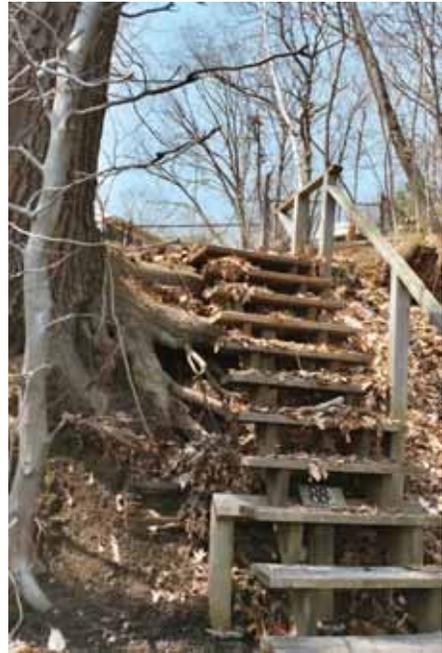
Erosion and Sedimentation on Slope

Recommended Actions / BMP's	<p>The clogged catch basins on the dead end of Lakeview Road need to be cleaned out, and the pipe connecting to the outfall should be inspected to insure that flow is not obstructed in the line. Once flow is restored from these catch basins to the outfall, the slope erosion problem should be ameliorated</p> <p>Given the high degree of sediment buildup both at the dead end catch basins and in Finley's Cove, pre-treatment for total suspended solids before discharge to the lake is recommended. This could be accomplished with the replacement of the existing catch basins with deep sump catch basins. Estimated cost of these is about \$2500 to \$3,000 each. There are two catch basins at the dead end of Lakeview Road, and there are about 10 that are tributary to Finley's Cove. Another alternative for the Finley's cove area could be the installation of a hydrodynamic separator before the stormwater is directed to the outfall. This could capture and retain much of the sediment in one location for the entire subdrainage area. There are several hydrodynamic separators commercially available (see Appendix). Preliminary cost estimate is \$50,000 (\$35,000 for the unit and \$15,000 for installation. For either type of BMP, maintenance will be critical.</p>

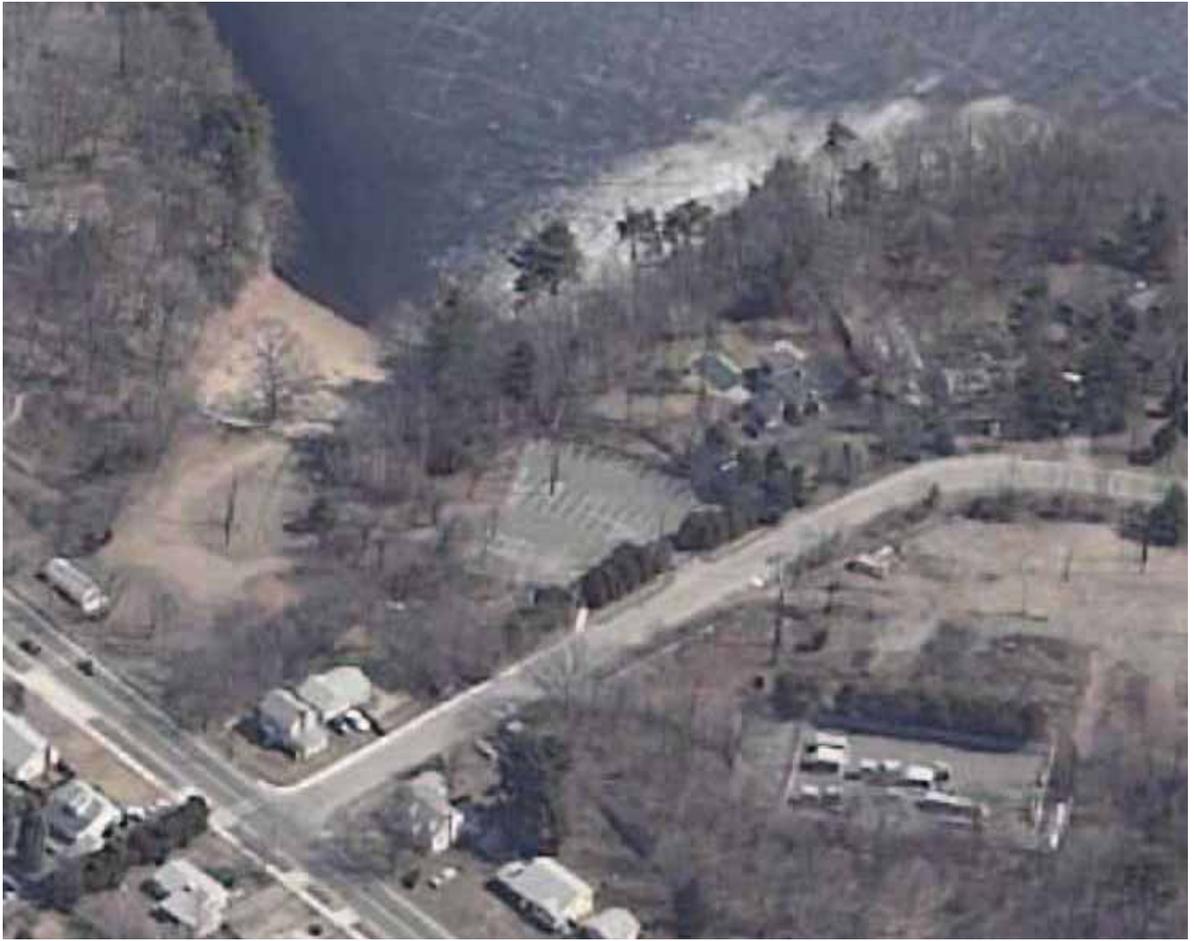
Pictometry View of Framingham Town Beach and Adjacent Parking Lot

SITE NP-FR-2	Framingham Town Beach
Location	Corner of Old Connecticut Path and Lake Road, Framingham
Site Description:	The site has a moderately steep slope from the road down to the shoreline; the upper part of the site is partially paved and partially grassed, the lower part of the site is the sand beach. A stormwater outfall is located next to the swimming beach; this discharges runoff from the beach parking lot.
Issue/Problem	<p>(1) Erosion: runoff from the upper portion of the site causes erosion on the lower part of the site. An asphalt walkway concentrates the runoff, causing erosion which has formed a shallow gully along the west edge of the site.</p> <p>(2) Runoff: the parking lot outfall discharges directly to the swimming beach.</p>
Recommended Actions / BMP's	<p>(1) Erosion: site drainage could be reconfigured to avoid the concentration of runoff. This could be done with regrading and the addition of a vegetated buffer strip to collect and slow the runoff before it is discharged.</p> <p>(2) Runoff: A pre-treatment device should be added to the stormwater system. Given confined space, a hydrodynamic separator would be the best option. A similar proposal for this site was submitted to EPA by the Framingham Planning Dept. as a Supplemental Environmental Project in 2001. BMP's proposed included improvements to catch basins, relocation of existing stormwater inlets, and installation of a sediment settling chamber. The cost was \$133,500. An updated cost estimate for 2004 is about \$150,000.</p>

- Site drainage could be reconfigured to avoid the concentration of runoff which is causing erosion above the beach. This could be done with regrading and the addition of a vegetated buffer strip to collect and slow the runoff before it is discharged.

- A pre-treatment device should be added to the stormwater system. Given confined space, a hydrodynamic separator would be the best option. Such a system could remove most suspended sediments and other pollutants associated with the sediments.

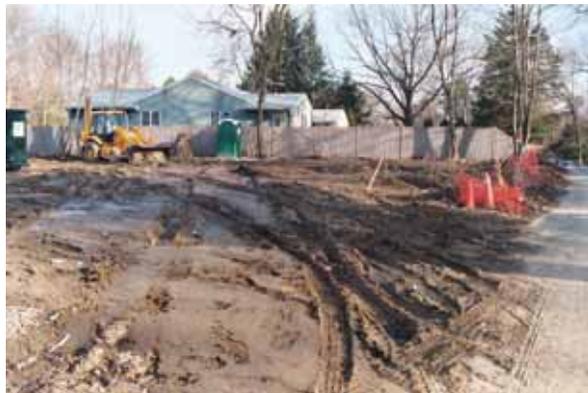
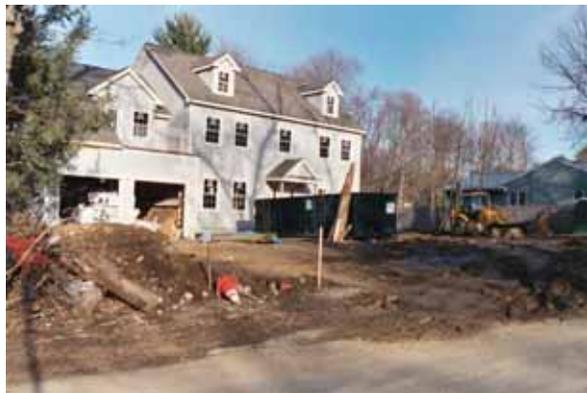
Site #1A, Edgewood Road

SITE NP-WA-1A SITE NP-WA-1B SITE NP-WA-1C	Residential construction sites
Location	Lake Road, Edgewood Road, and Morrill Road in Wayland
Site Description:	There are three single family homes under construction, in the neighborhood adjacent to North Pond. Each is a separate single-lot development.
Issue / Problem	All three construction sites have extensive areas of disturbed earth and show evidence of some erosion, and neither site has any visible erosion control measures in place. Stormwater from all of these sites is collected in nearby catch basins and discharges directly to North Pond.
Recommended Actions / BMP's	Basic erosion control measures such as silt fences and hay bales should be used on sites like this during the construction period. Most likely these were not required in these cases because each is a single house lot that would not trigger the requirement for subdivision review ("Approval Not Required," or ANR). In the future, the town could adopt erosion and sedimentation measures that apply even when subdivision approval is not required. This might be accomplished with a local erosion and sedimentation bylaw (see Chapter 6).

- Erosion control measures such as silt fences and hay bales should be used on all construction sites, including single-lot “Approval Not Required” (ANR) homes. Towns should adopt erosion and sedimentation measures that apply even when subdivision approval is not required. This might be accomplished through amendments to the building code.

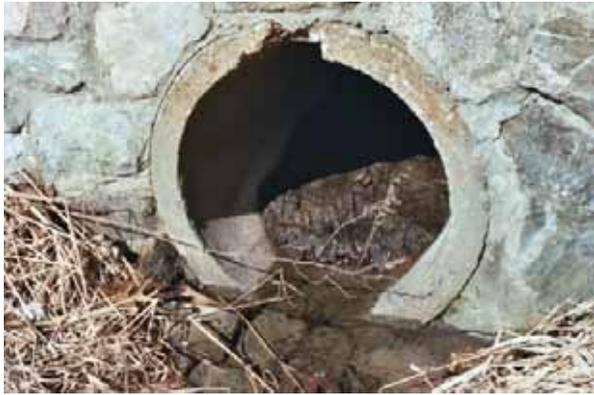
SITE NP-WA-2	Stormwater outfall at Wayland Town Beach
Location	Wayland Town Beach, off of Parkland Street
Site Description:	A stormwater outfall discharges to North Pond on the south side of the Wayland Town Beach. The outfall discharges stormwater from the parking lot next to the beach and adjacent town roads.
Issue / Problem	The outfall location results in the discharge of stormwater directly in the area of the town beach. This is a direct discharge with no mitigation of stormwater quality. A discharge of this sort would not be in compliance with DEP stormwater standards today. The outfall pipe has several inches of sediment and muck deposits in it which have an oily appearance. Reinspection of this site in spring 2004 found that much debris had accumulated below the outfall, and a makeshift grate had been placed over the outfall, secured by some logs.
Recommended Actions / BMP's	Since this is a town owned facility and is heavily used by the public, it is recommended to mitigate this stormwater discharge, which could not only improve this site, but also serve as a demonstration project. The site could be retrofitted to provide pre-treatment of the stormwater before it is discharged to the lake. A potential mitigation measure for the parking lot portion of the stormwater is the retrofitting of low impact development techniques that provide filtration through vegetated buffers. A similar site in Acton is being retrofitted with Filterra units, which may be useful for this site (see Appendix). For the overall flow coming from adjacent town roads, the installation of a pretreatment device such as a hydrodynamic separator is recommended. The estimated cost of this option would be about \$50,000, \$35,000 for the unit and \$15,000 for installation. After the installation of BMP's, ongoing maintenance will be critical to their performance in order to achieve water quality benefits.

Sediment build-up in the pipe (April 3003)

- The site should be retrofitted to provide pre-treatment of stormwater before it is discharged. A potential mitigation measure for the parking lot is the retrofit of low impact development techniques that provide filtration through vegetated buffers
- For the overall stormwater flow coming from adjacent town roads, the installation of a pretreatment device such as a hydrodynamic separator is recommended.

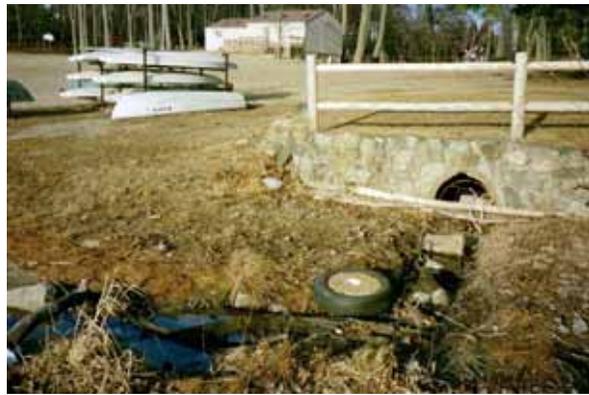
Debris accumulation (March 2004)

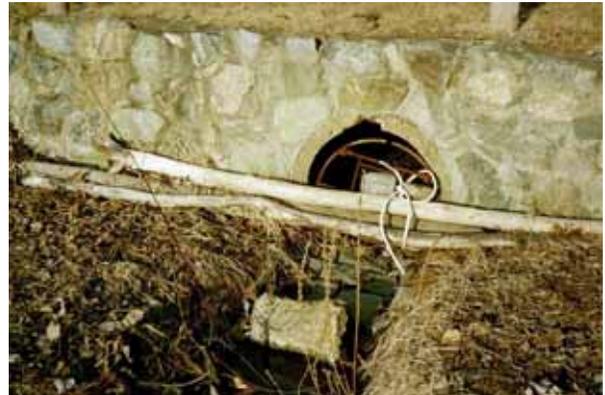
Grate secured by logs (March 2004)

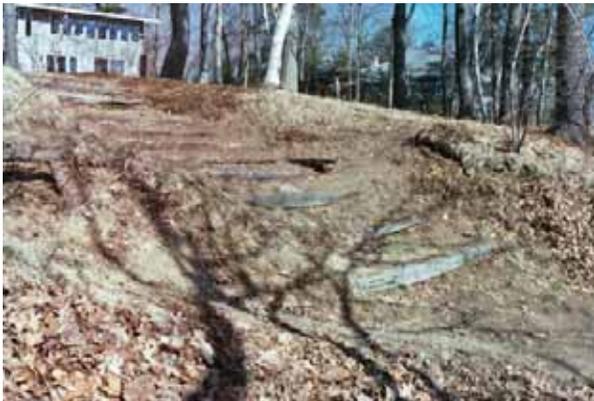
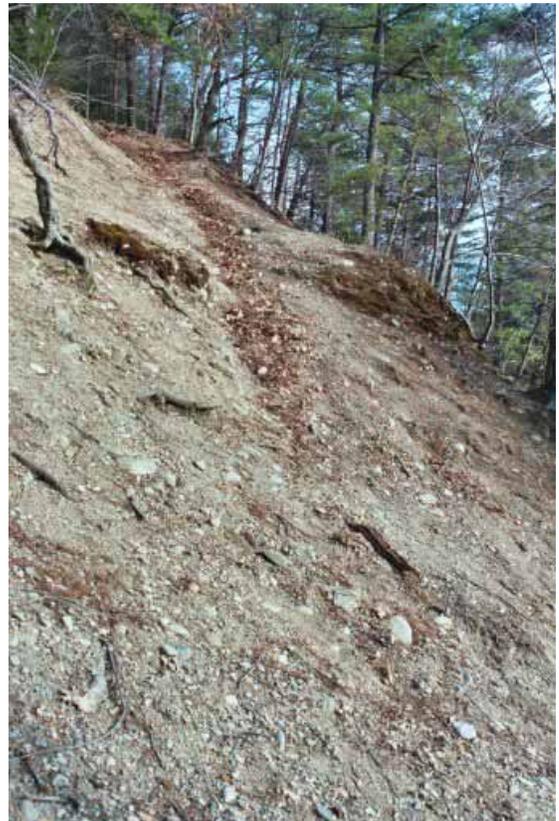
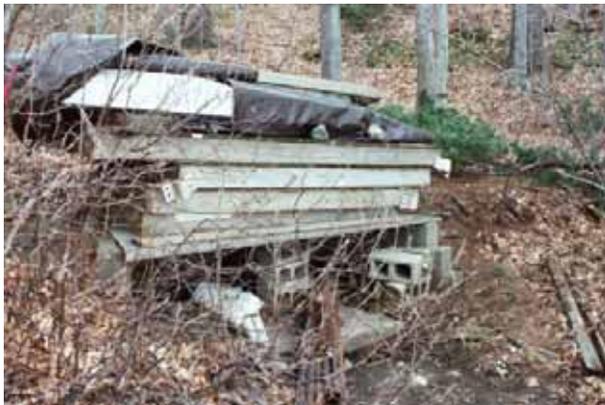
SITE NP-FR/WA-1	Shoreline of North Pond in Framingham & Wayland
Location	Residential areas of Wayland and Framingham
Site Description:	Several of the residents with property abutting the North Pond shoreline have adopted practices which have potential impacts on the lake. These include: (1) dumping of leaves, yard waste, and brush onto the steep slopes of the lake's shoreline (2) installation of stairs and paths on the lake's steep slopes to provide access to the shoreline; and (3) installation of docks on the lake and use of motor craft on the lake
Issues / Problems	(1) Since the lake already has elevated inputs of phosphorus, disposal of leaf and yard waste on the shoreline could exacerbate nutrient loading problems. (2) Improper management of steep slopes can lead to erosion, and increased sediment loads to the lake. (3) Boating activity, particularly motor craft, can resuspend sediments, cause shoreline erosion, and has potential impacts from fuel, oil, and greases.

Recommended Actions / BMP's	These practices should be addressed by public education and outreach measures (see the public education brochure for this project). Speed limits for boats should be posted by the Dept. of Conservation and Recreation

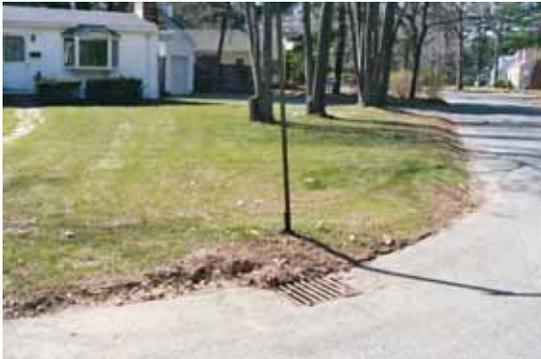
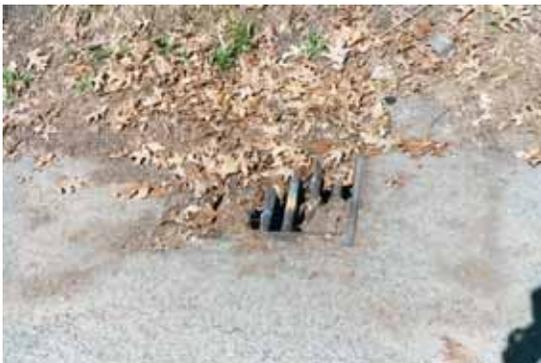
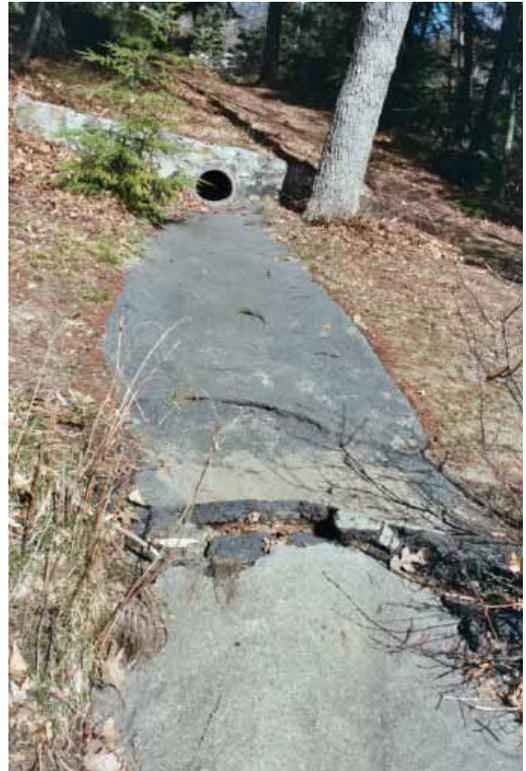
SITE NP-FR/WA-2	Stormwater discharges from residential areas
Location	Areas adjacent to North Pond in Framingham and Wayland
Site Description	There are 9 stormwater outfall discharges to North Pond, 5 in Wayland and 4 in Framingham, that discharge stormwater runoff from residential areas.
Issues / Problems	Discharges from these outfalls have the potential for conveying stormwater pollutants typical of residential land uses and streets, including nutrients, sediments, bacteria, oils and greases, and pesticides. Potential sources of nutrients may include fertilizers applied to lawns and gardens, and wastewater leachate from septic systems or leaking sewer lines. Sources of sediments include street debris and erosion from construction or landscaping activities. Bacteria can come from pet wastes and malfunctioning septic systems or leaking sewers. Oils and greases are related to vehicles and roadway runoff, and pesticides may be used in lawn and garden maintenance.

Recommended Actions / BMP's	All of these potential pollution sources should be addressed by public education and outreach measures. These will be included in the public information brochure produced for this project. In addition, stormwater pollution can be reduced by frequent street sweeping and cleaning of catch basins. In some cases, retrofitting with deep sump catch basins would reduce the pollutant load in stormwater.

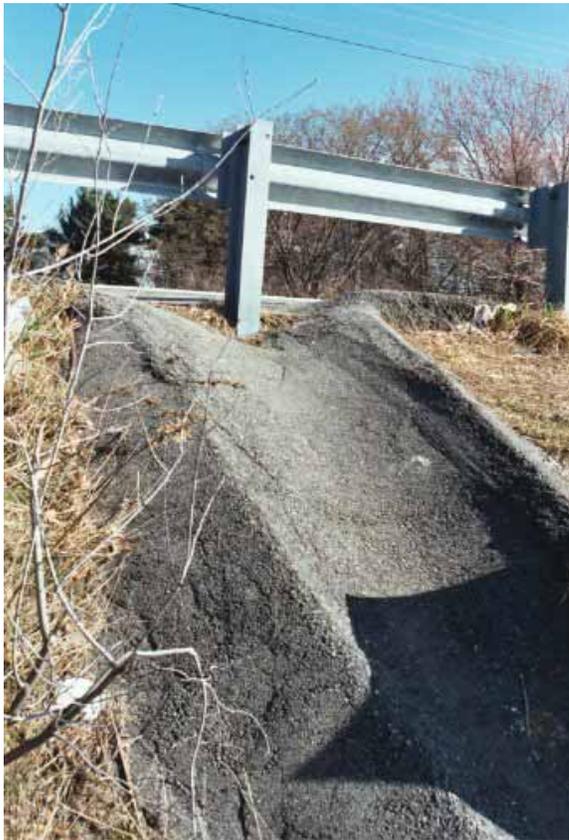
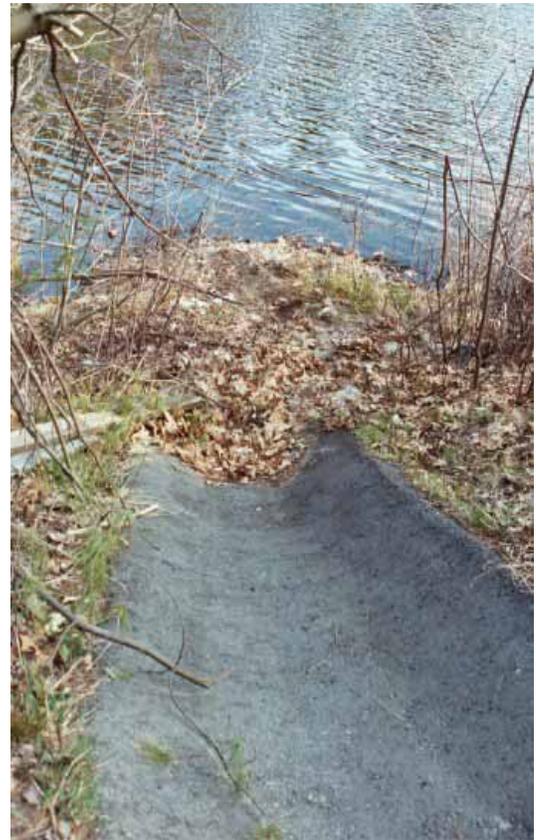
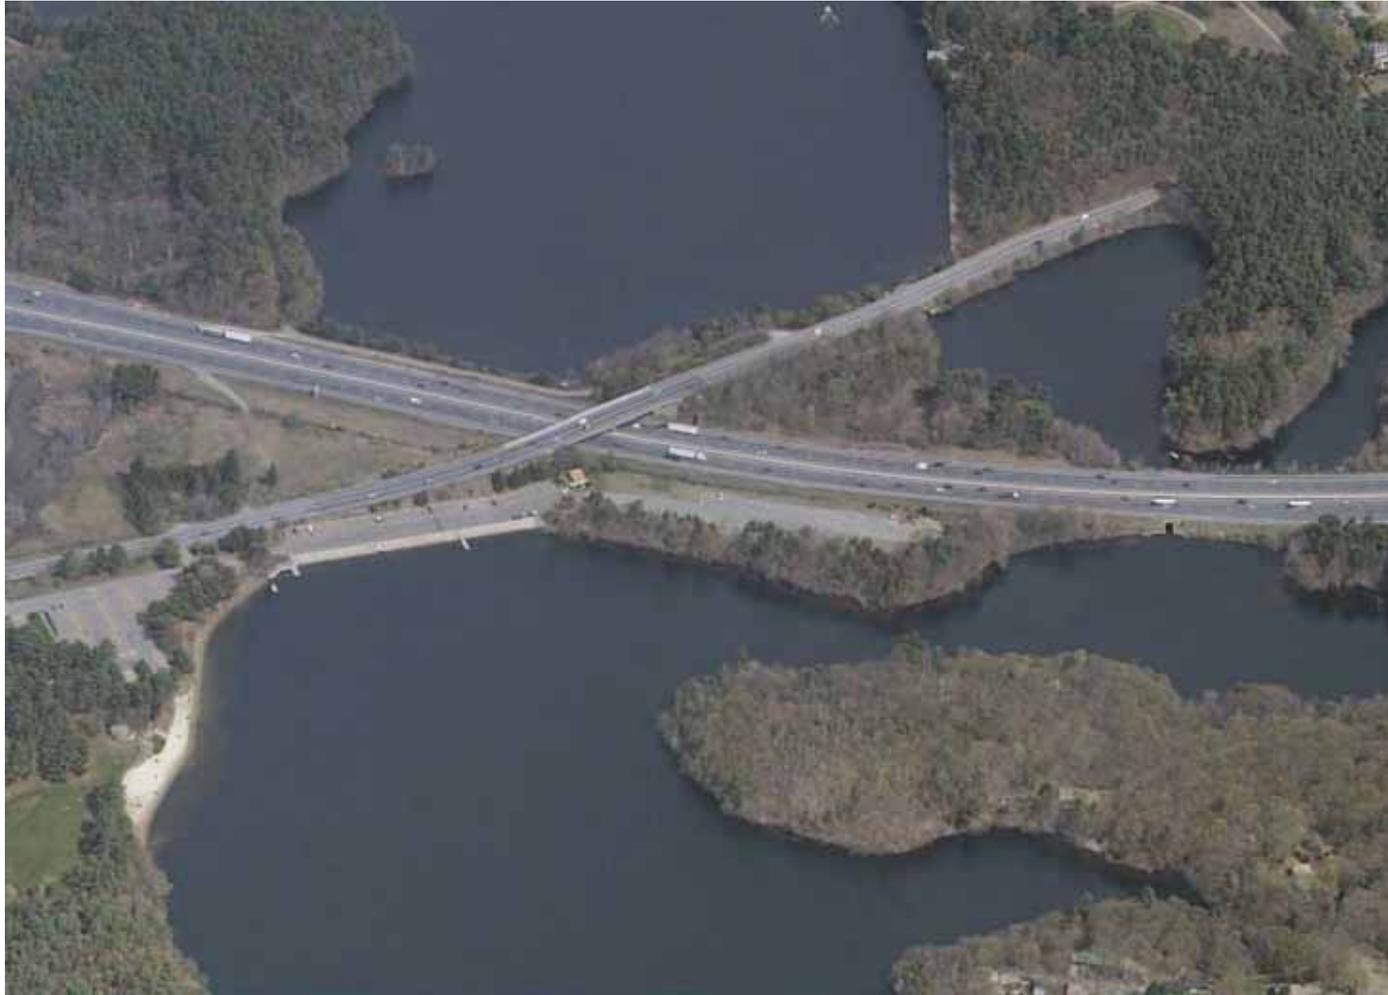
Pictometry View of the Mass. Turnpike & Route 30 Crossing Lake Cochituate (North Pond, Snake Brook Pond, & Middle Pond)

SITE NP-WA-3	Stormwater discharges from Route 30
Location	Route 30 as it crosses the culvert between North Pond and Snake Brook Pond
Site Description:	Route 30 discharges stormwater directly to North Pond and Snake Brook Pond about ¼ mile east of where it passes over the Massachusetts Turnpike. There are 4 paved drainage swales on the westbound lane of Rt. 30 that discharge to North Pond, and 3 paved swales that discharge to Snake Brook Pond.
Issue / Problem	The direct discharges of roadway runoff have no measures in place to mitigate stormwater quality. There is evidence of build up of sediments, organic material, and litter at the bottom of each of the drainage swales. The abutment on the east bound lane also shows signs of erosion of steep slopes. Discharge of road salts in winter runoff is also a concern. This kind of direct discharge of untreated stormwater would not comply with current DEP stormwater guidelines.

Recommended Actions / BMP's	The Mass. Highway Department should consider installation pre-treatment devices such as hydrodynamic separators to reduce the sediment and pollutant load to the lake. This would also require installation of catch basins and piping in this area. In addition, the existing erosion on steep embankments should be corrected. Preliminary cost estimate for installing these BMP's is \$250,000.

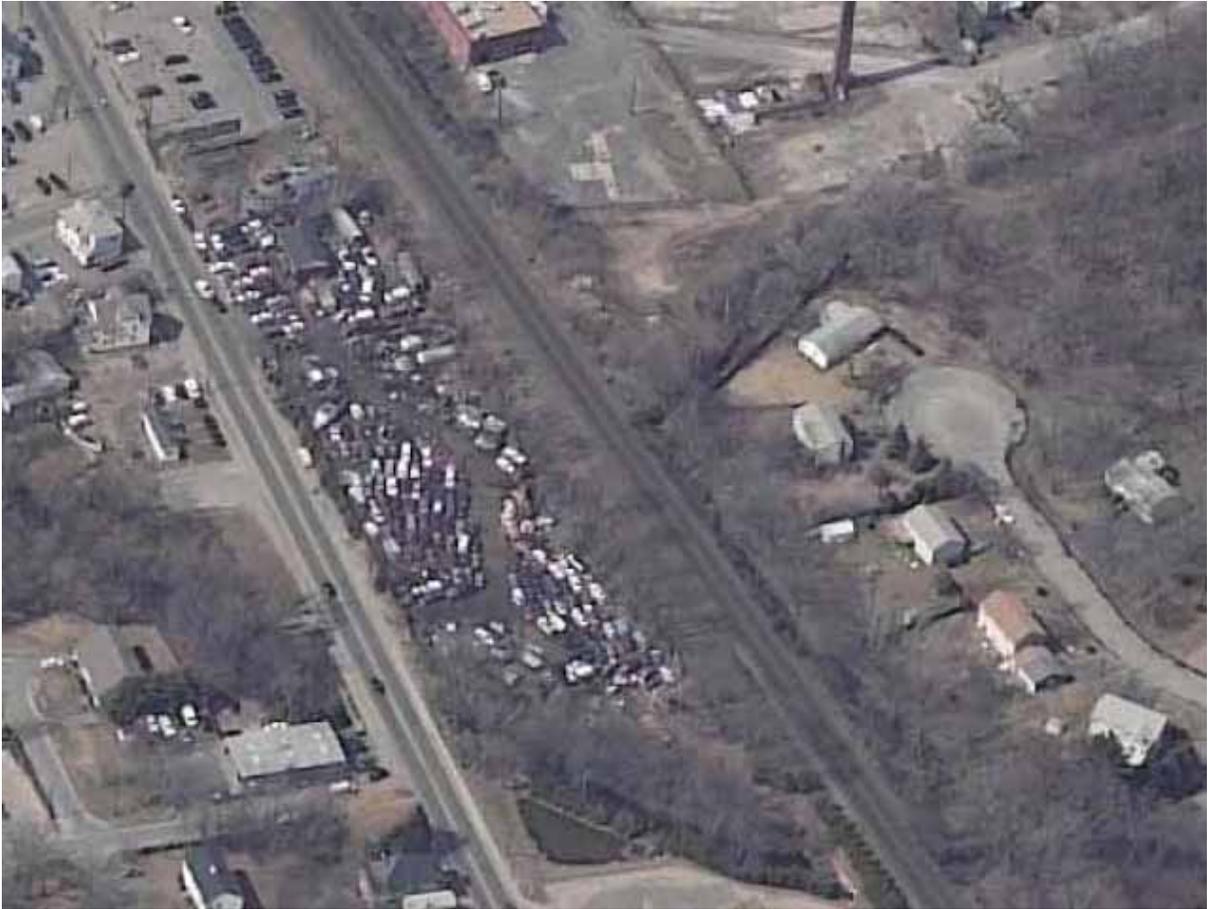
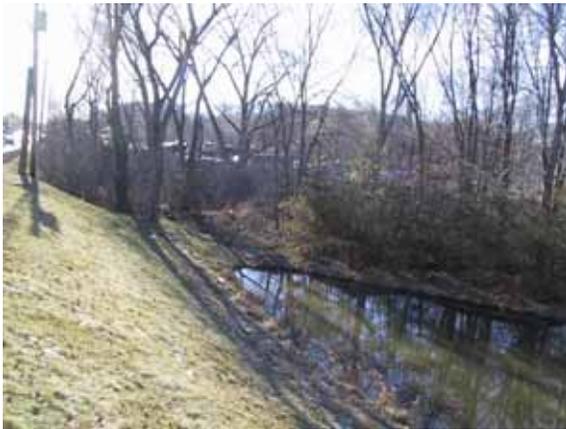
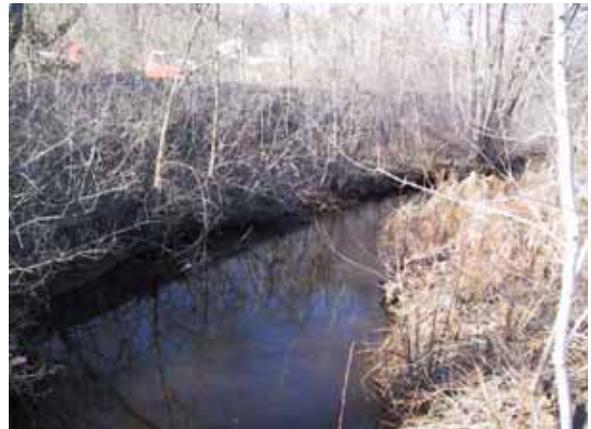
LAKE COCHITUATE PRIORITY SUB-WATERSHED ASSESSMENT AREA 2: Beaver Dam Brook Sub-watershed	
SITE BB-NA-1	Central Street Used Auto Parts of Natick
Location	327 West Central Street, Natick
Site Description	A used auto parts site and 21 E site with partially paved lot area abutting Beaver Dam Brook.
Issue/Problem	<ul style="list-style-type: none"> • Stormwater from site drains west towards vehicle entrance/exit driveway, out onto West Central St. (Route 135), into catch basins and then to Beaver Dam Brook • Possible VOC, metals, others from site • Turbidity and sedimentation
Recommended Actions / BMP's	<p>Site drainage could be redirected away from West Central Street by constructing a berm along the western (stream side) and northern edges of the property. Flows would be directed into a vegetated swale on the western side of the lot inside the berm. Check dams in the swale would slow flows and help TSS to drop out into swale. A detention basin could be constructed in the southeast corner of the lot to treat first flush stormwater with an overflow bypass to Beaverdam Brook for flows > 2-5 year storm. Site is about 1 acre. Estimated cost would be about \$300,000.</p>

This photo is the detention basin in the bottom left corner of the top photo

This photo is Beaver Dam Brook beside the bottom of 327 West Central Street in Natick (top photo)

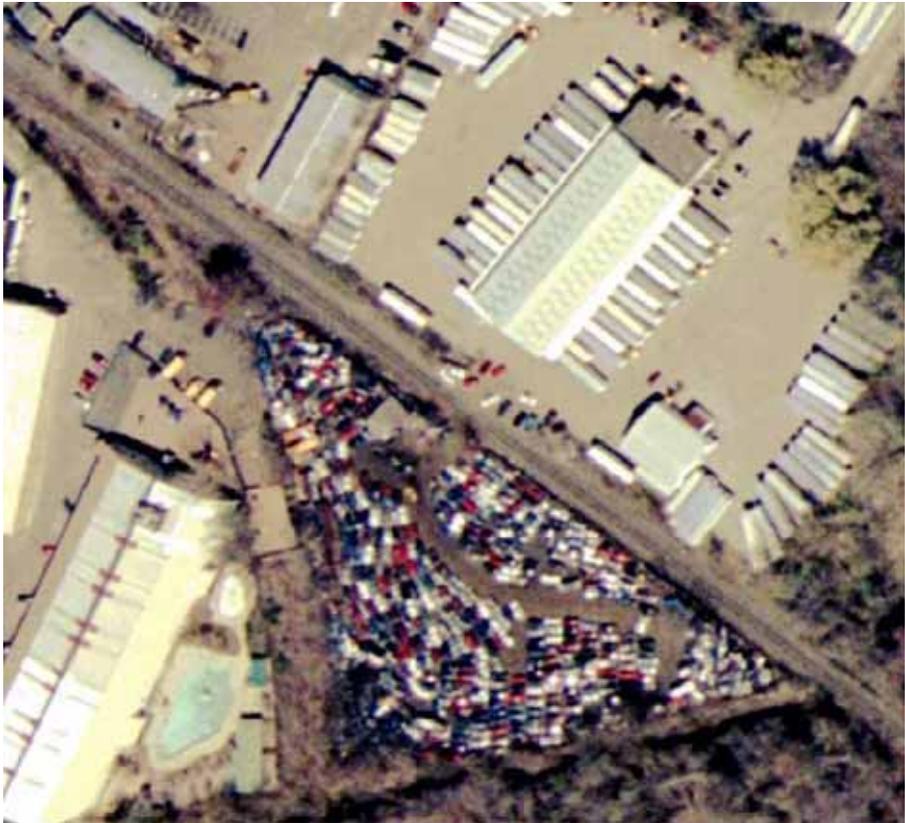
LAKE COCHITUATE PRIORITY SUB-WATERSHED ASSESSMENT	
AREA 2: Beaver Dam Brook Sub-watershed	
SITE BB-FR 2	A-1 Used Auto Parts
Location	115 Rear Beaver Street, Framingham
Site Description	Used auto parts yard abuts Beaver Dam Brook
Issue / Problem	<ul style="list-style-type: none"> • Stormwater runoff to Beaver Dam Brook • Possible VOC, metals, others from site • Turbidity and sedimentation
Recommended Actions / BMP's	Site drainage could be redirected away from wetland areas by constructing a berm along the southern (stream side) and western edges of the property. Flows would be directed into a vegetated swale on the southern side of the lot inside the berm. Check-dams in the swale would slow flows and help TSS to drop out into swale. A detention basin could be constructed in the southeast corner of the lot to treat first flush stormwater with an overflow bypass to Beaverdam Brook for flows greater than a 2-5 year storm. Site is about 1 acre. Estimated cost would be about \$300,000.

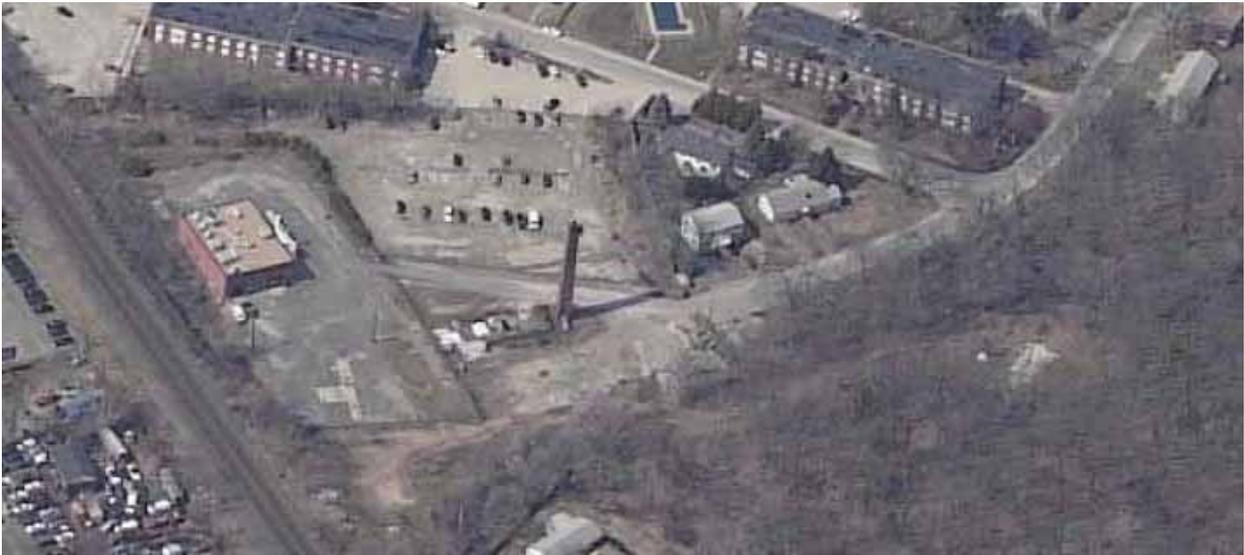
LAKE COCHITUATE PRIORITY SUB-WATERSHED ASSESSMENT AREA 2: Beaver Dam Brook Sub-watershed	
SITE BB-FR 3	Municipal Property, Public Works storage yard and MWRA EXT Pump Station
Location	Arthur Street, Framingham
Site Description	Framingham Department of Public Work yard, abuts Beaver Dam Brook and the Natick town line.
Problem	This is a two-parcel site of about one acre in total size and is paved. This site contributes significant flows of untreated stormwater runoff along with heavy TSS loads from the parking/storage areas into a tributary stream of Beaverdam Brook. Sheet flow runs from west to east across both the MWRA yard and the DPW site into the stream.
Recommended Actions / BMP's	A possible approach to this problem would include the construction of a pitched swale along the eastern edges of both the MWRA pump station site and the DPW yard. The swale would help attenuate TSS by directing stormwater flows towards four deep sump catch basins with attached Vortechs units for first flush treatment of stormwater. Flows greater than a 2-5 year storm would be bypassed via overflow piping to the tributary stream. Estimated cost would be about \$200,000.

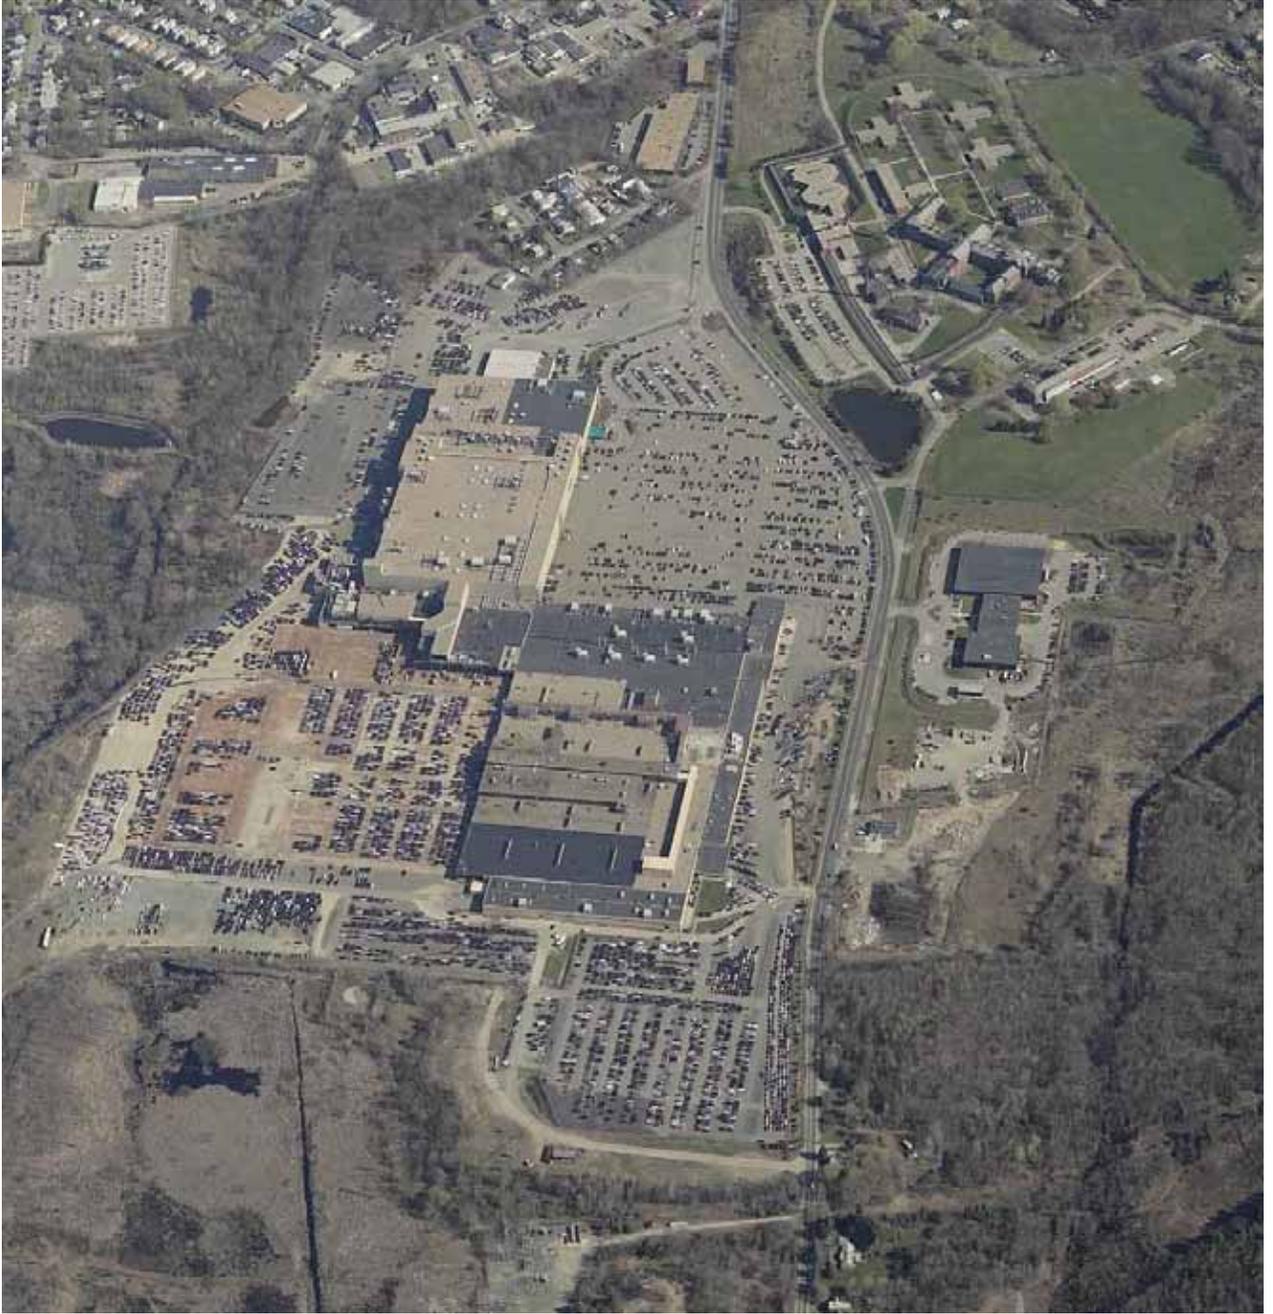
Adesa Auto Auction of Boston site (former GM plant)

PRIORITY SUB-WATERSHED ASSESSMENT	
AREA 2: Beaver Dam Brook Sub-watershed	
SITE BB-FR 4	Adesa Auto Auction of Boston site
Location	63 Western Avenue, Framingham
Site Description	Large parking and auto storage facility at former GM plant site: largest single impervious site in Lake Cochituate watershed at about 108 acres in size.
Problem	<ul style="list-style-type: none"> • Very large impervious area with no apparent stormwater detention ponds or other controls • During storm events and winter melt, this site may be contributing nonpoint source pollution to Beaver Dam Brook • Notice of Intent filed with Framingham CC in 1999 to remove buildings on site but no Order of Conditions or Certificate of Compliance on record • Turbidity and sedimentation • Contact with company officials has not yielded information regarding stormwater system
Recommended Actions / BMP's	Existing storm water controls for the site need to be determined. A detailed analysis of existing outfalls and their condition, the number of feet of pipe, manholes and catch basins needs to be determined. Possibly dedicate large detention basin across from existing basin west of the central portion of the site and just east of Beaverdam Brook. Two large TSS removal units would precede the basin or a series of smaller TSS units could be placed further up the drainage area piping system for collection. At least 1000 feet of piping, 15 catch basins and detention basin in addition to TSS removal would mean that this project would cost in the \$500,000 range.

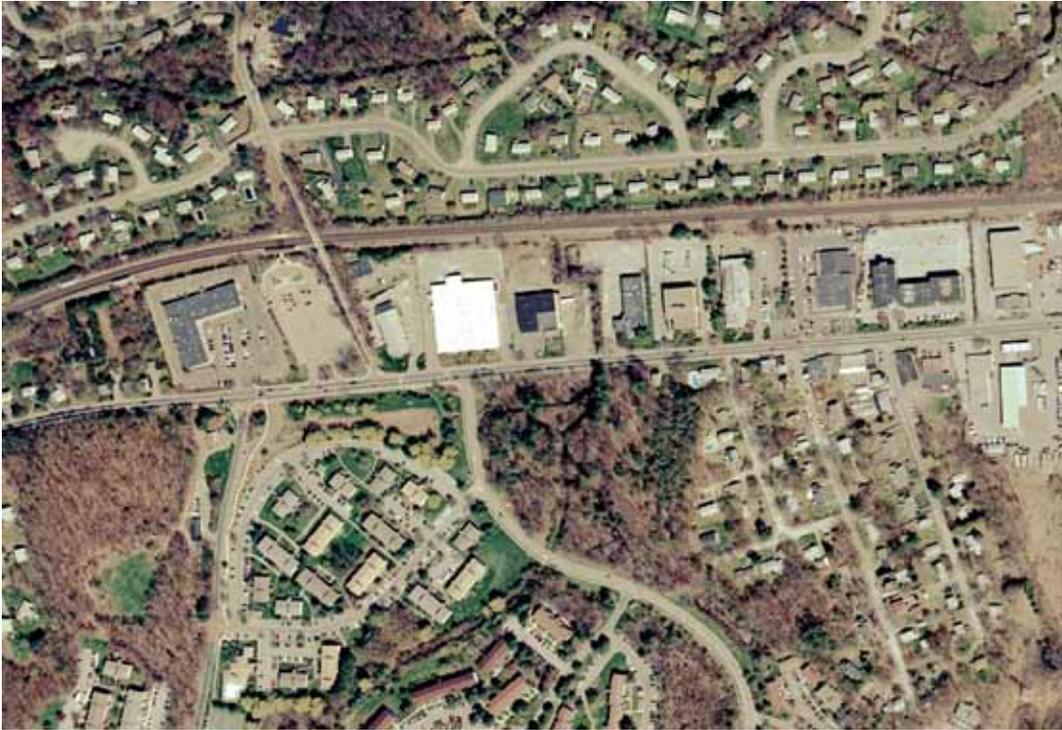
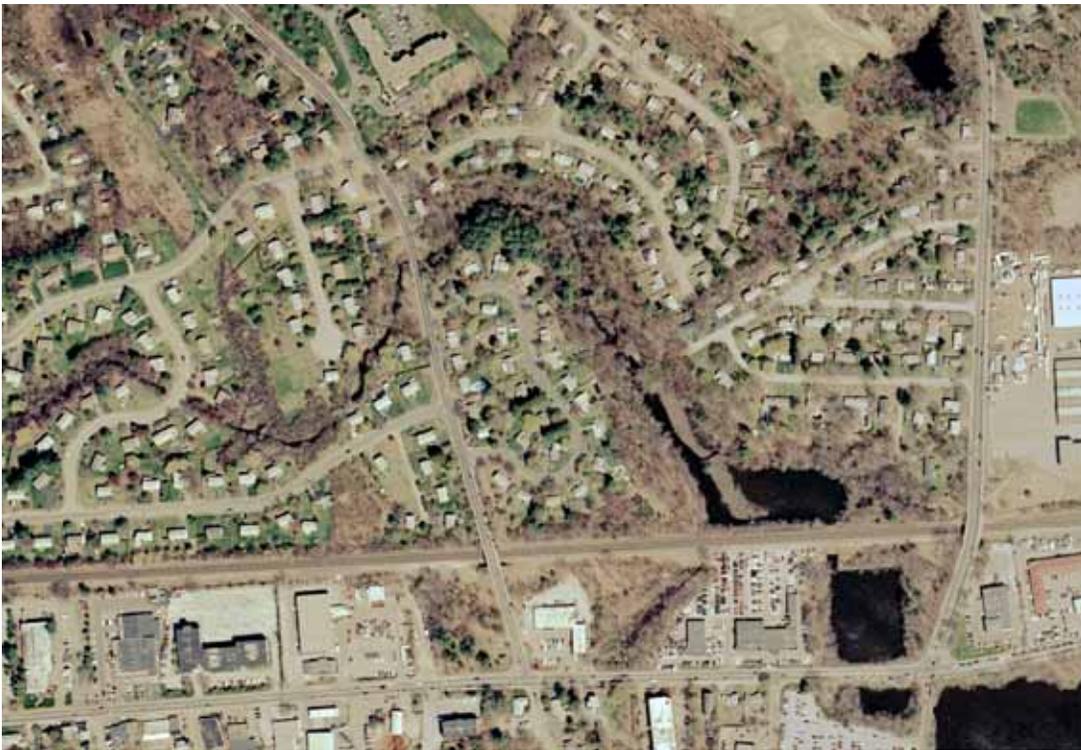
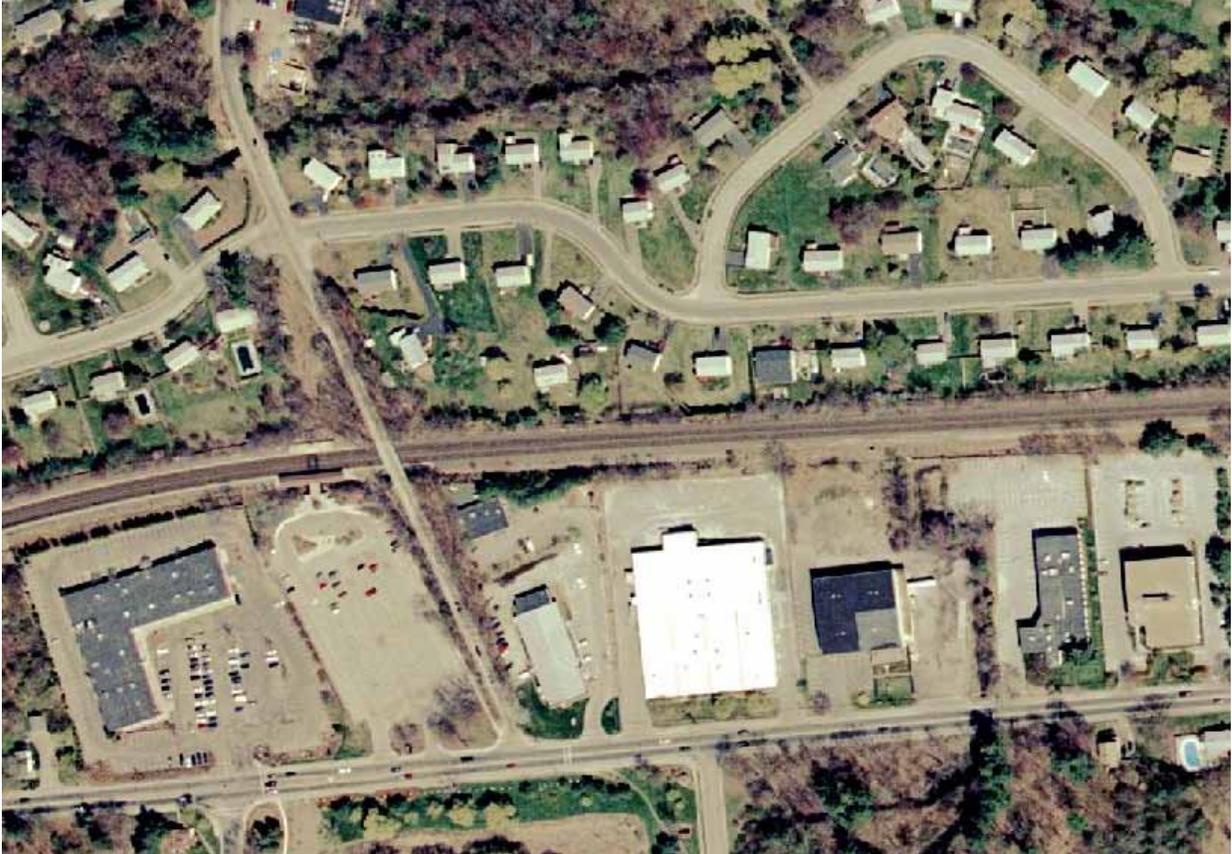
LAKE COCHITUATE PRIORITY SUB-WATERSHED ASSESSMENT AREA 2: Beaver Dam Brook Sub-watershed	
SITE BB-NA-5	West Central Street Commercial Area
Location	Area bordered by Boden Lane to the west and Mill Street to the east, RR tracks to north and West Central Street to south , Framingham.
Site Description	Roughly 116-acre commercial/industrial district with high percentage of impervious area just south of Beaverdam Brook. The site has been delineated into three delineated NPS sites: 1) the Comcast site at 241 West Central, 2) 233-235 West Central Street, and the 3) the Barber Brothers parcel just east of the 233-235 West Central St.
Problem and Recommended Action/BMP	<p>Site 1: About 26-acres in size. Currently, sheet flow is running west to east across a paved parking area in front of and around the Comcast Building to Beaverdam Brook. The stone collecting swale presently in place would be replaced with a it with a series of 5 catch basins placed at 100-foot intervals alongside the stream. The first flush would be handled by TSS removal units for each catch basin and the basins would be equipped with overflow devices (estimated cost, \$80,000).</p> <p>Site 2: Approximately 6-acres in size, this portion of the overall site is paved and its sheet flow runs from west to east to Beaverdam Brook on its western border. Attenuation here could be accomplished by placing a series of three catch basins in the existing low area of the site to treat flows. TSS removal units would accompany each catch basin and overflows could be run to the existing pocket wetland onsite (estimated cost, \$70,000).</p> <p>Site 3: Just east and south of Barber Brothers, a series of existing catch basins collect untreated stormwater where it is piped underneath the RR tracks and then to Beaverdam Brook. A possible solution here would be insert into a drain line manhole an appropriately sized TSS removal unit as close as possible to the RR tracks to gain maximum treatment benefit (estimated cost, \$50,000).</p>

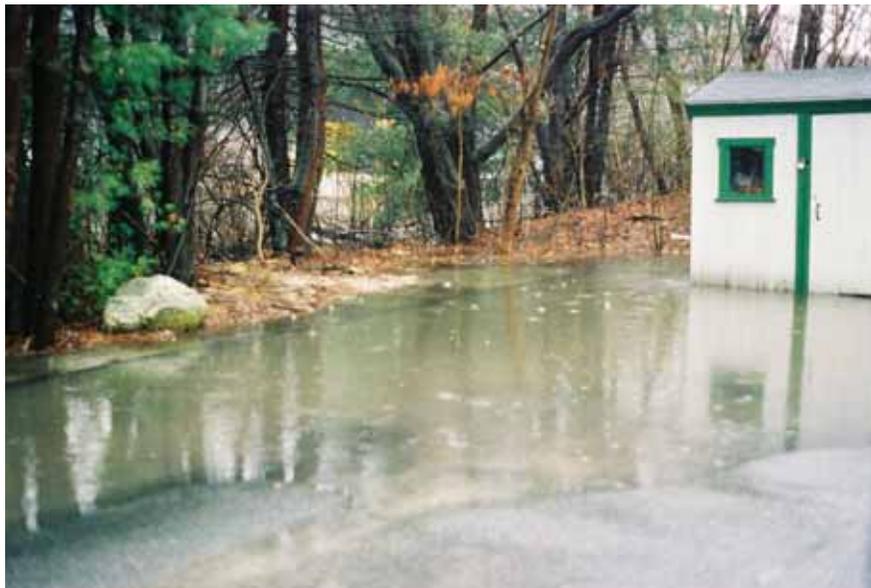
Photos show parking lot drainage directly emptying to and impacting the drainage tributary draining to Beaver Dam Brook

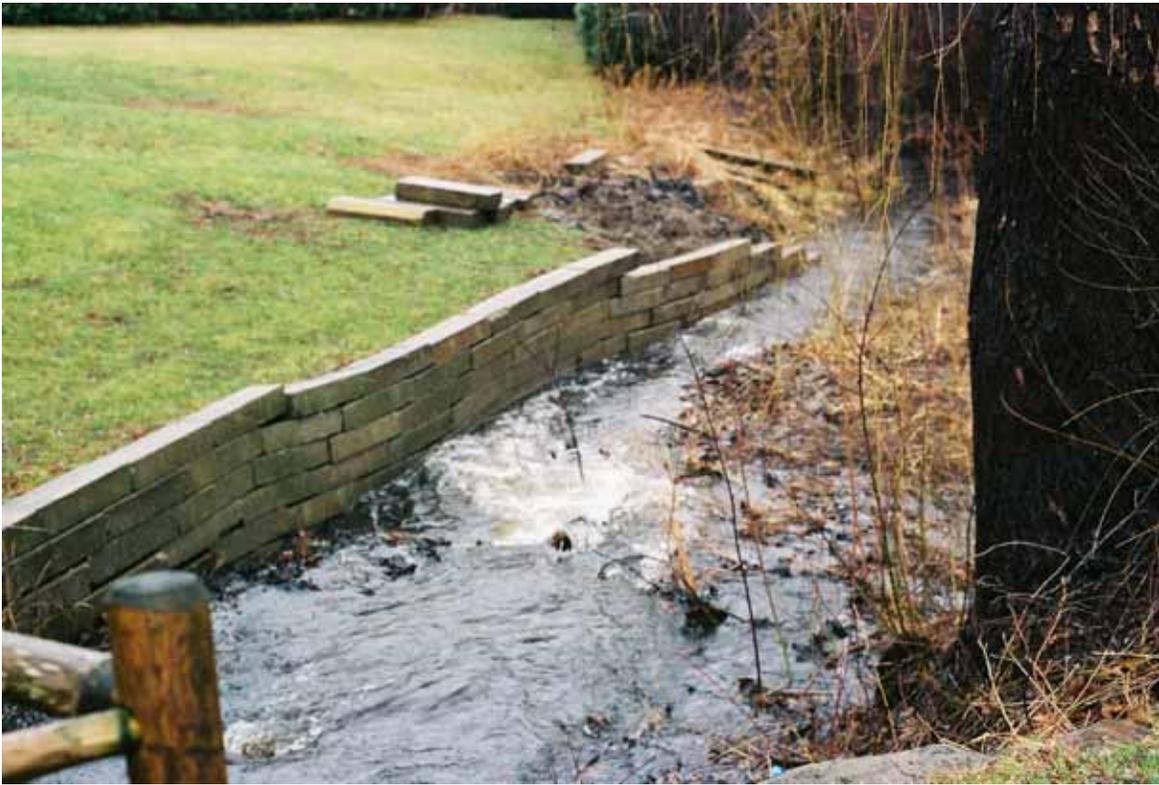
Photo shows a sample effort to channelized part of Beaver Dam Brook. The idea behind this effort is to reclaim lawn space and stop the brook from encroaching on the homeowner's land

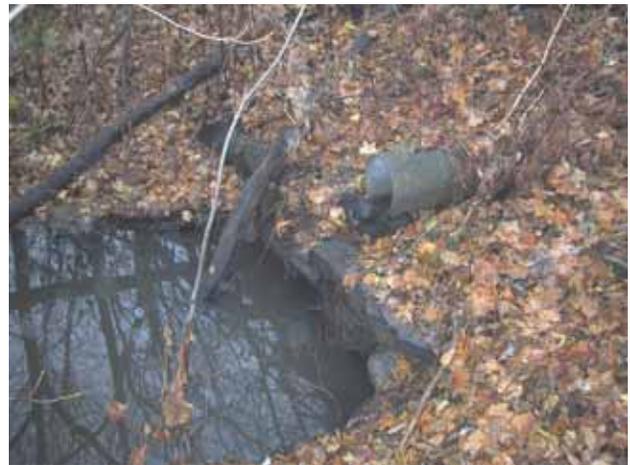
LAKE COCHITUATE PRIORITY SUB-WATERSHED ASSESSMENT AREA 3: Pegan Brook Sub-watershed	
SITE PB-NA-1	Failing catch basin and outfall
Location	Lake Street and LaGrange
Site Description	1 Lake Street floods after storm events due to poor catch basin design 2 Additional sedimentation at the outfall due to no rip rap
Problem	1 As a result of the failed catch basins lots of mud forms and siltation is easily discharged to the reduced capacity catch basin. 2 As the stormwater discharge exits the outfall pipe velocity stirs up the sediments and a muddy plume heads down stream
Recommended Actions / BMP's	1 Add a deep sump catch basin to hold sediments before discharge to stream 2 Add rip rap at the outfall discharge point to trap and slow effluent 3 Add a small asphalt berm to direct flows toward catch basin and to keep vehicles on the pavement Estimated cost of these measures, \$15,000

The outfall from the adjacent catchbasin discharges silt and mud from the street. The receiving pool is filled with a muddy plume leading to the mouth of Pegan Brook.
