5.0 WATERSHED ACTION PLAN FOR PRIORITY SUBBASINS

LAKE COCHITUATE PRIORITY SUB-WATERSHED ASSESSMENT	
AREA 1: North Pond Sub-watershed	
SITE NP-FR-1	Lakeview Road Drainage
Location	Lakeview Road, Framingham
Site Description	Lakeview Road is a residential street that runs along the shore of North Pond. Stormwater from this area is collected in a series of catch basins and discharged directly to North Pond through a series of four outfall pipes (see Map 9).
Issues/Problems	<p>1) Where Lakeview Road dead ends near the bank of North Pond, there are two catch basins that are not collecting the stormwater flow from the road because they are clogged. As a result of the failed catch basins, stormwater overtops the curb at the dead end of Lakeview Road and flows overland across the yard of the adjacent home, then rushes down the steep slope, causing significant erosion and sedimentation. The homeowner has a set of wooden stairs on the slope which show evidence of sediment deposition, and the roots of trees on the slope have been scoured and undercut by the stormwater flow. Framingham's drainage plan shows these 2 catch basins connected to the outfall southeast of the site. But it appears tha

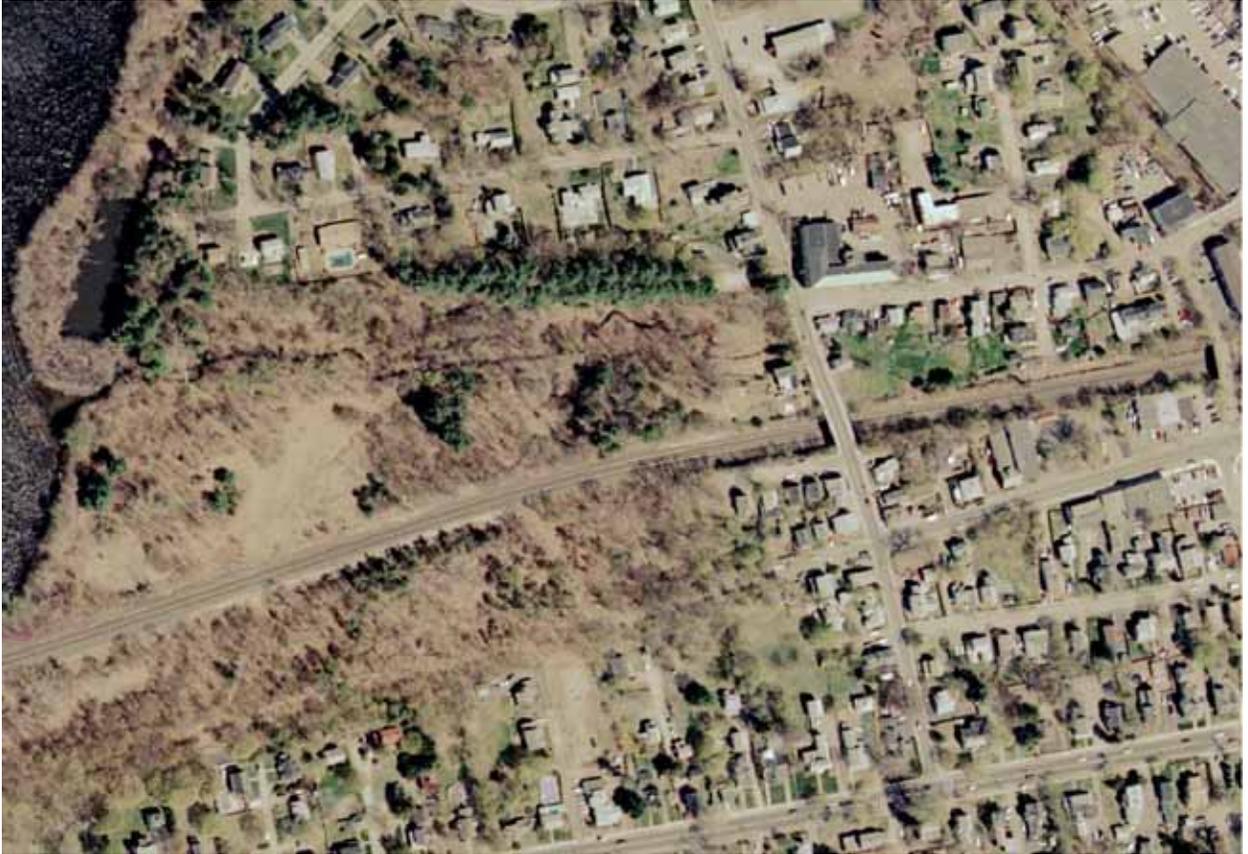
Problems	<p>No visible maintenance or upkeep of the existing stream bed (See page of photos with past construction project debris)</p> <p>Ponding and meandering of stream appears natural in some place and manmade in others, there is no organized plan for water's flow</p> <p>A visible sand delta at the mouth of Pegan Brook</p>
Recommended Actions / BMP's	<ol style="list-style-type: none"> 1 Area is prime for a constructed wetland system, complete with a forebay, ponds, & wetland chambers all to be located above the existing water quality structure. This up stream area could potentially incorporate and encompass flows from the PB-NA #3 site. Presently the park has areas that appear to have been ponding areas in the past. 2 Work with the EOE's Wetland Restoration Program to develop a management plan for the surrounding wetlands and a design for the formal stream channel
Costs	Estimated costs could be over \$500,000.

An over view of Pegan Cove Park
Brook runs north of the RR tracks and almost parallel to the heavy tree in the middle of the photo

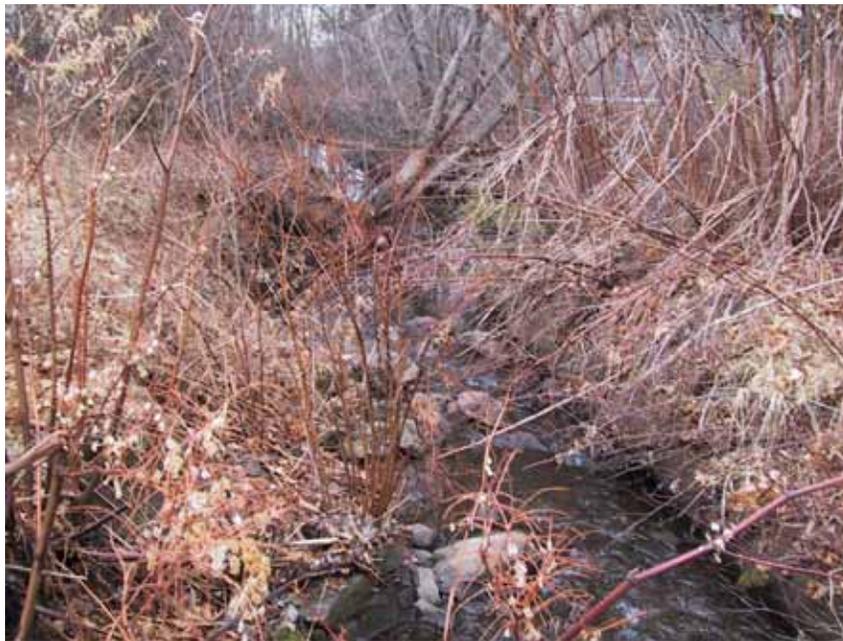
Photo shows the new movement of the streamway. Pegan Brook has been redirected several times. Thus the area in and around Pegan Park and the mouth of Pegan Brook has great wetland soils and lots of room for a man-made wetland system consisting of fore-bay and several chambers. Due to the history of filtering at the end of the stream this end of pipe solution would be nothing new.

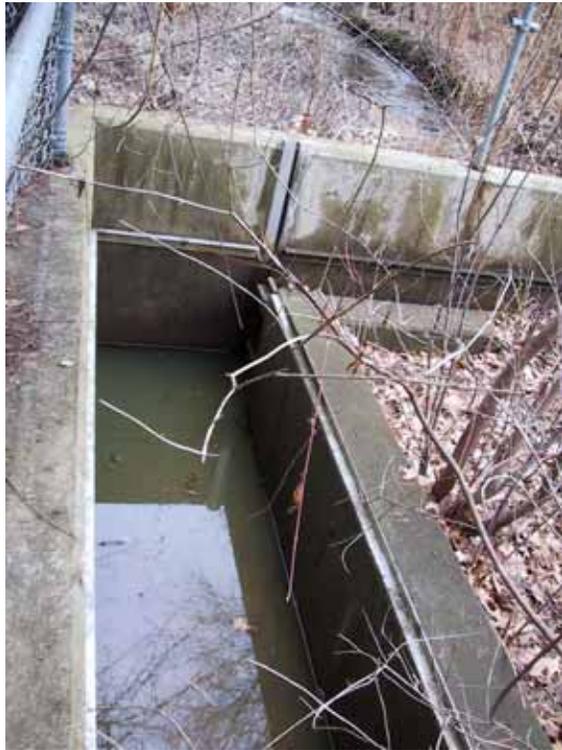
The structure below has no recorded history of upkeep or usage. Though the system seems to be working to slow the flow of water no purpose is known by the Town.

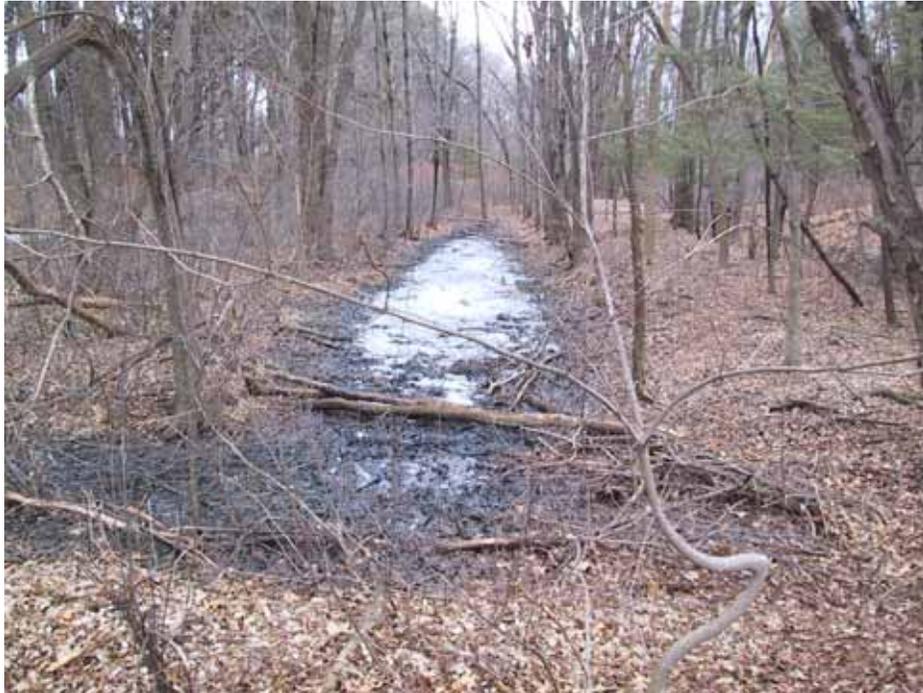
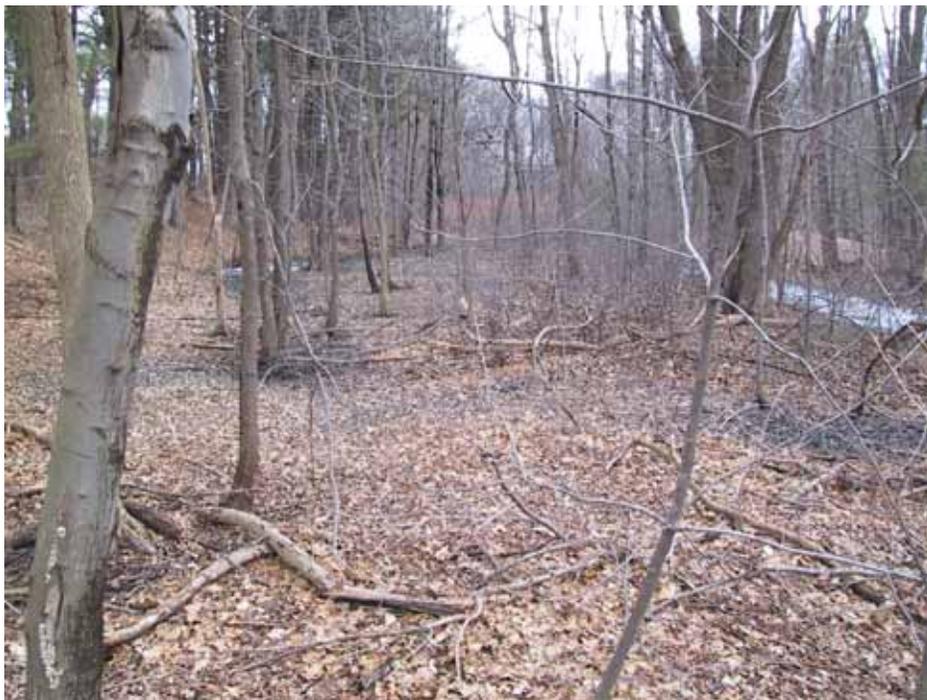
Presently Pegan Brook runs to the right of the top photo. The next photo is a swath of land alongside the brook. The photos appear to show what may have been ponding areas of the past. There is another area just west (30-40 yards) of this site that is presently ponding water but with some help could become much more efficient. The ability to pond and slow the flows of Pegan Brook could allow for pretreatment before entering the adjacent wetlands and ultimately Lake Cochituate.

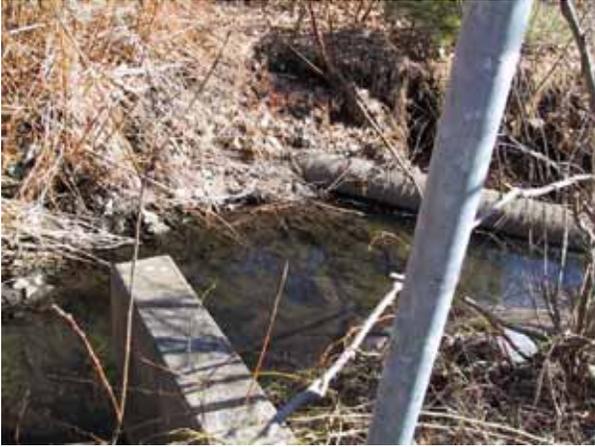
Pegan Brook as it flows around the hard structure in Pegan Cove Park, note the old pipe in the stream, this is a remnant from the old filter bed system

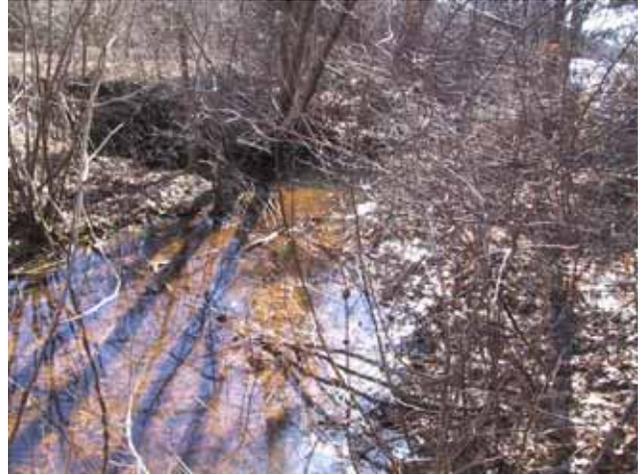
Effluent from the Pegan Cove park structure

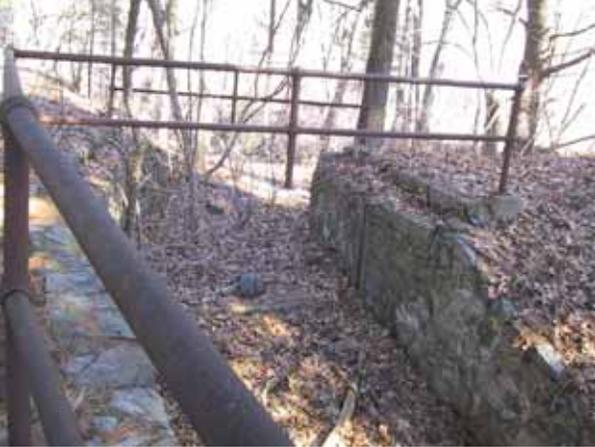
Remnant from the old dam structure used in the days of the original filter beds.

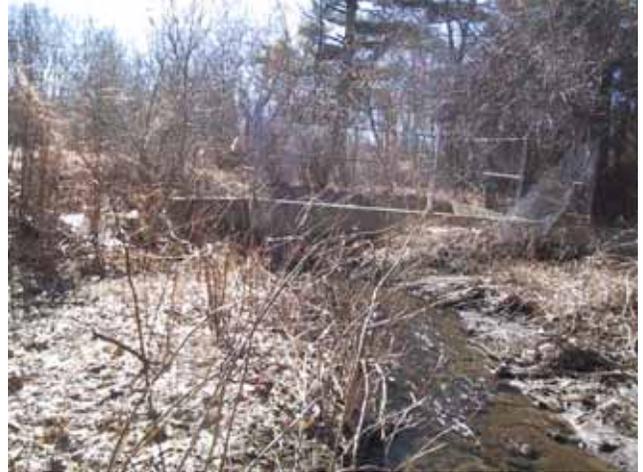
Front view of the hard structure in Pegan Cove Park

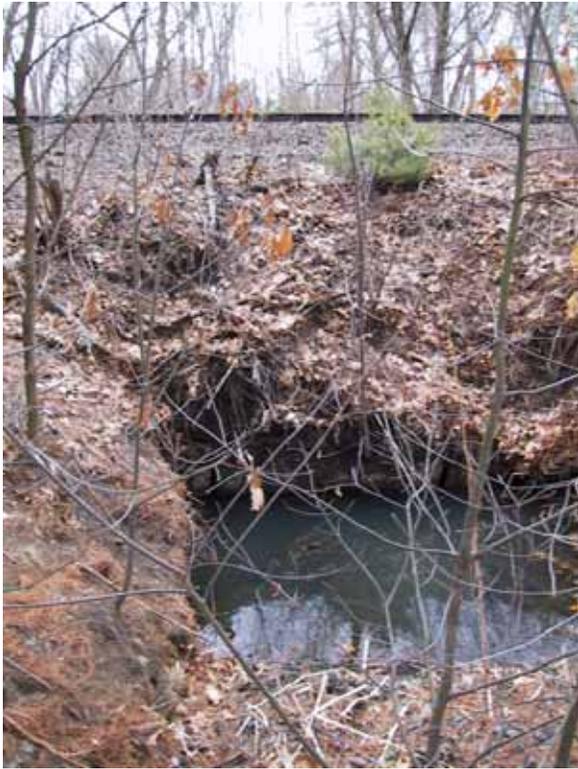
North of the railroad tracks
Two 24 inch steel pipes conduct flow from one wetland
to the other (Pipes under water, not visible in this
picture.)

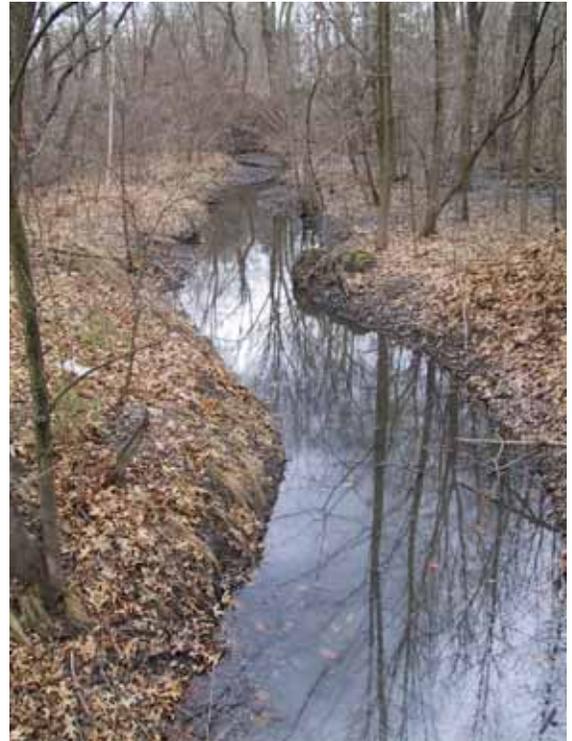
Water course on the South side of RR tracks.

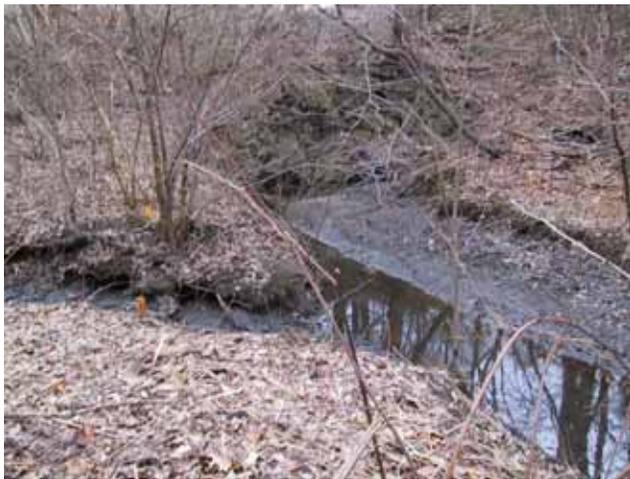
Stream way south of the RR tracks, picture shows
sediment build up and yard debris deposited by
neighbors

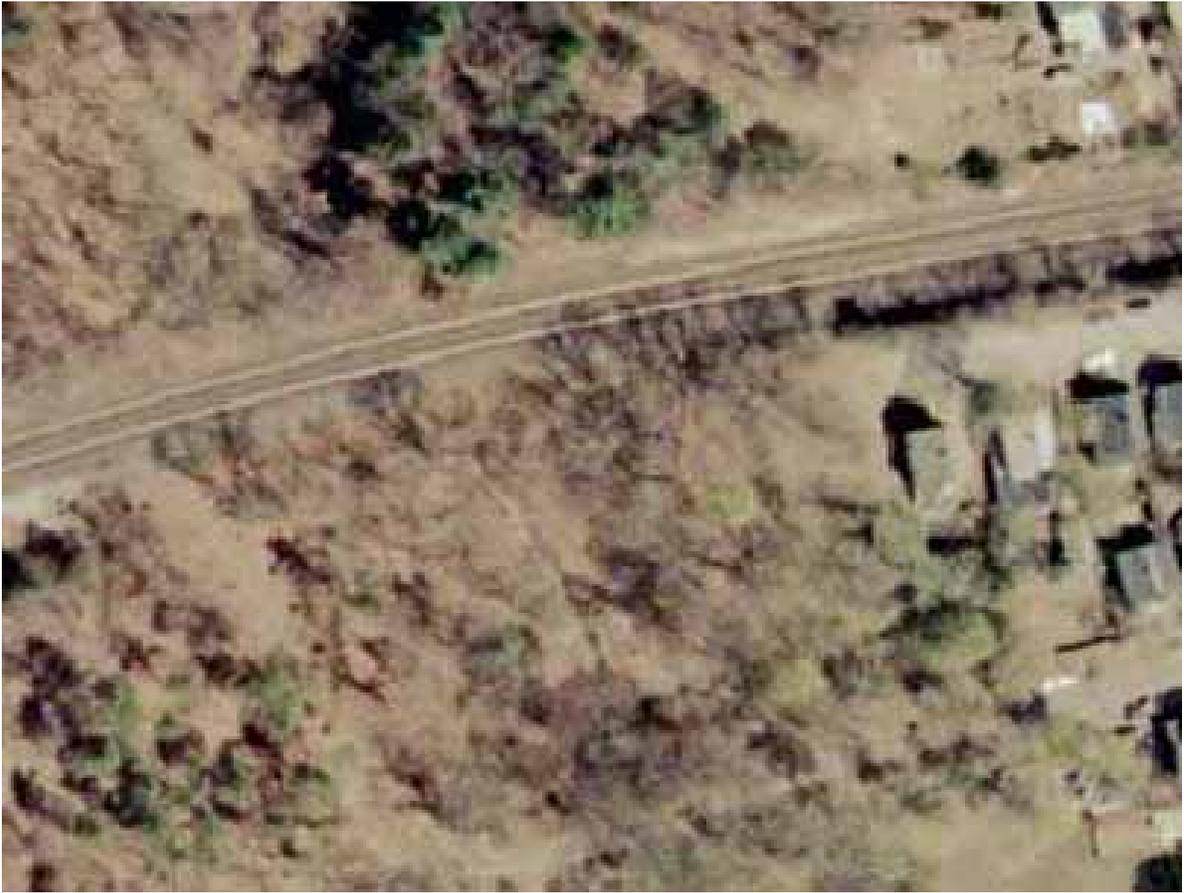
This photo is an aerial of site PB_NA 3
The stream can be seen in the center below the active RR tracks.
The old RR track location is at the very bottom of the picture

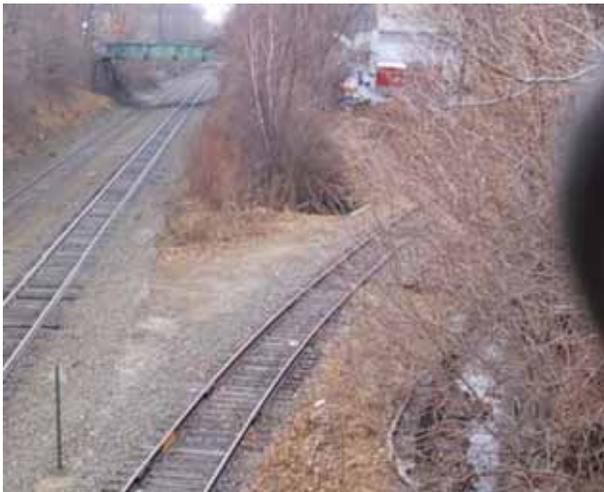
The weedy area between the RR tracks is a small ponding area of Pegan Brook. The Brook it self is the small light area in the bottom right of this photo.

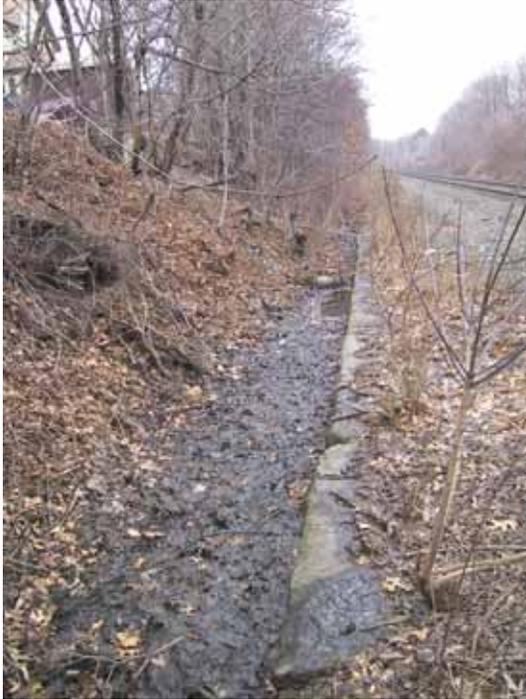
Note the sedimentation on the channelized stream bottom and the stained wall. Sedimentation is not found upstream of this site (see next photos).

Down stream view (siltation)

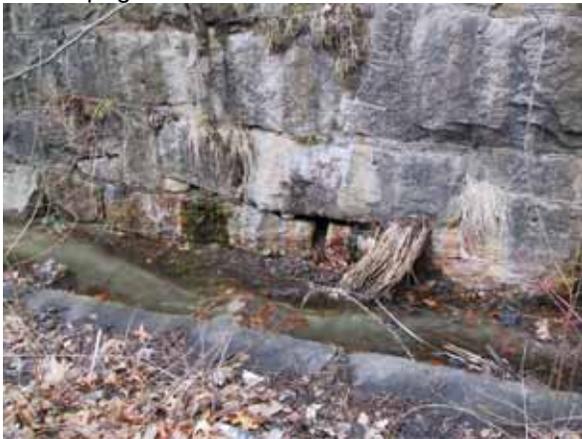
This drain pipe below shows no sign of discharge, this photo is right after the seepage points.

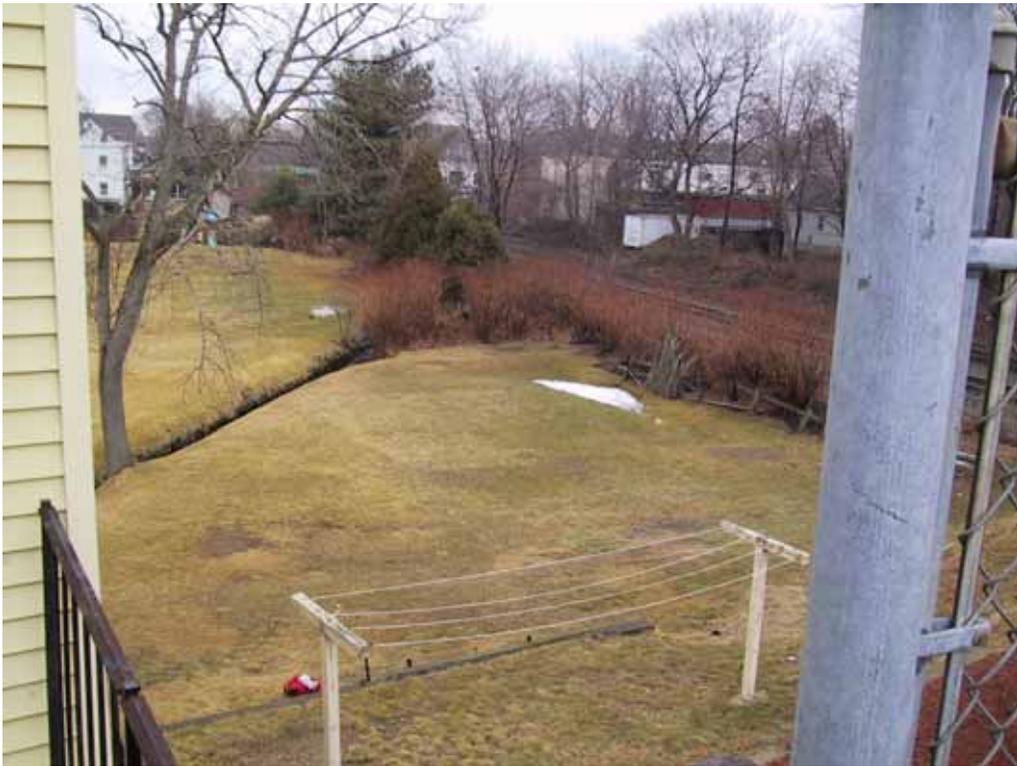
Any fertilizer or pesticide that is put on these lawns will be in the stream during the first rain event.

Recommended Actions / BMP's:	<ul style="list-style-type: none"> • Constructed wetland with a forebay to handle flows from the culverted flows south of the RR tracks (estimated cost, \$75,000) • Storm drain inserts to capture sediments and trash before dropping to the culvert cost approximately \$300-\$400 per unit x 8- 10 units • House run-off over grass filter strip before straight entrance to stream or a rain barrel for alternative water usage, this would require realigning the gutters on the house pictured below cost about \$300
