# MALDEN Climate Resiliency Planning

*City Parks Resiliency Assessment  
and Recommendations*

PREPARED FOR:  
**City of Malden**

PREPARED BY:  
**Shadley Associates P.C.**

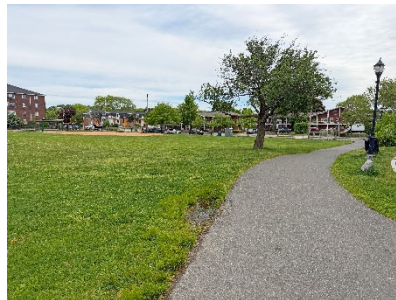
The tree canopy within the park is mature and dense in the southern portion of the site where a network of walkways lined with benches provides ample opportunities to rest in the shade. The canopy consists of deciduous and evergreen trees that are generally in good condition. However, near the playground and ballfield, the tree canopy becomes sparse with a few shade trees located around the playground and within the adjacent streetscape. The park appears to be largely free of

*Ballfield and open lawn*

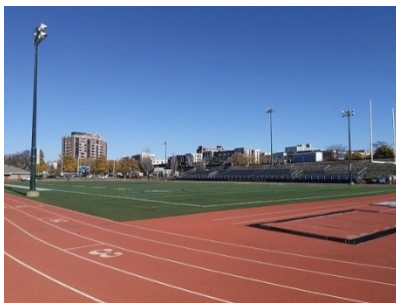
MacDonald Stadium is an important asset to the City of Malden and provides the community with access to modern and well-kept athletic facilities. The synthetic turf field receives regular use and after nearly 15 years of use it will likely need to be replaced. This replacement presents an opportunity to incorporate resiliency improvements into the site which will be discussed in the next section of this report.

*MacDonald Stadium track and field*

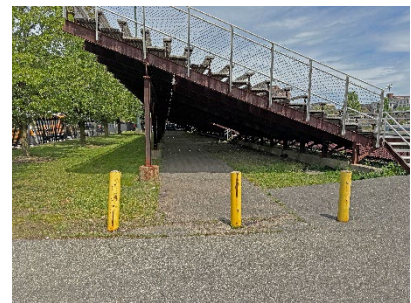
There are no visible green infrastructure systems in place at MacDonald Stadium. It is assumed that all stormwater is collected in below grade systems. An existing slot drain follows the edge of the perimeter asphalt walkway at the north end of the site. In the parking lot at the southwest corner of the stadium there is a large concrete-encased utility structure in the pavement that, according to Malden GIS, is a drainage structure. It is unclear whether this drainage structure captures stormwater runoff from the stadium, the surrounding neighborhood, or both.

*Home stands and southwest parking lot*
